**Board of Property Maintenance Appeals
Board Meeting**

**February 11, 2021
5:30 PM**

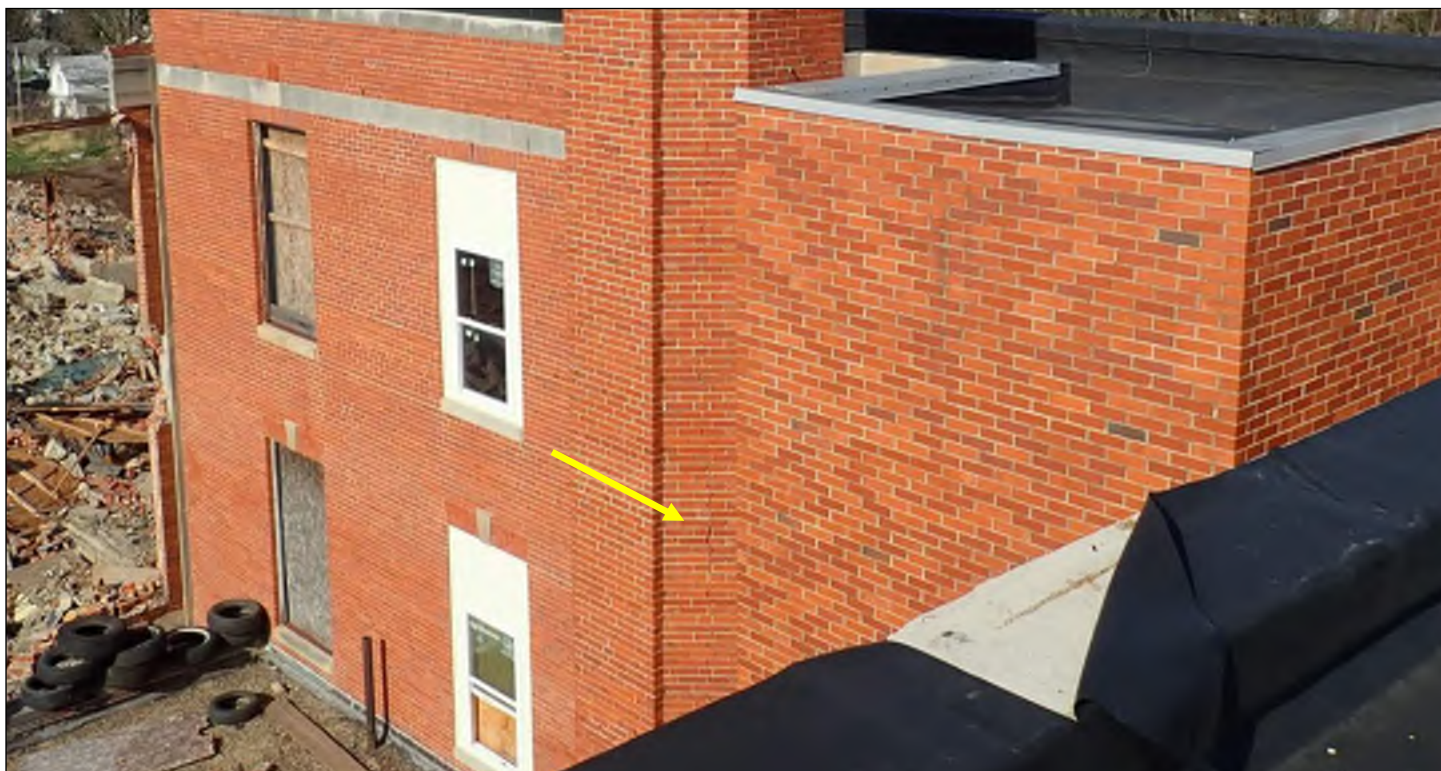
Photo 18: Vertical crack in smokestack brick (arrow).

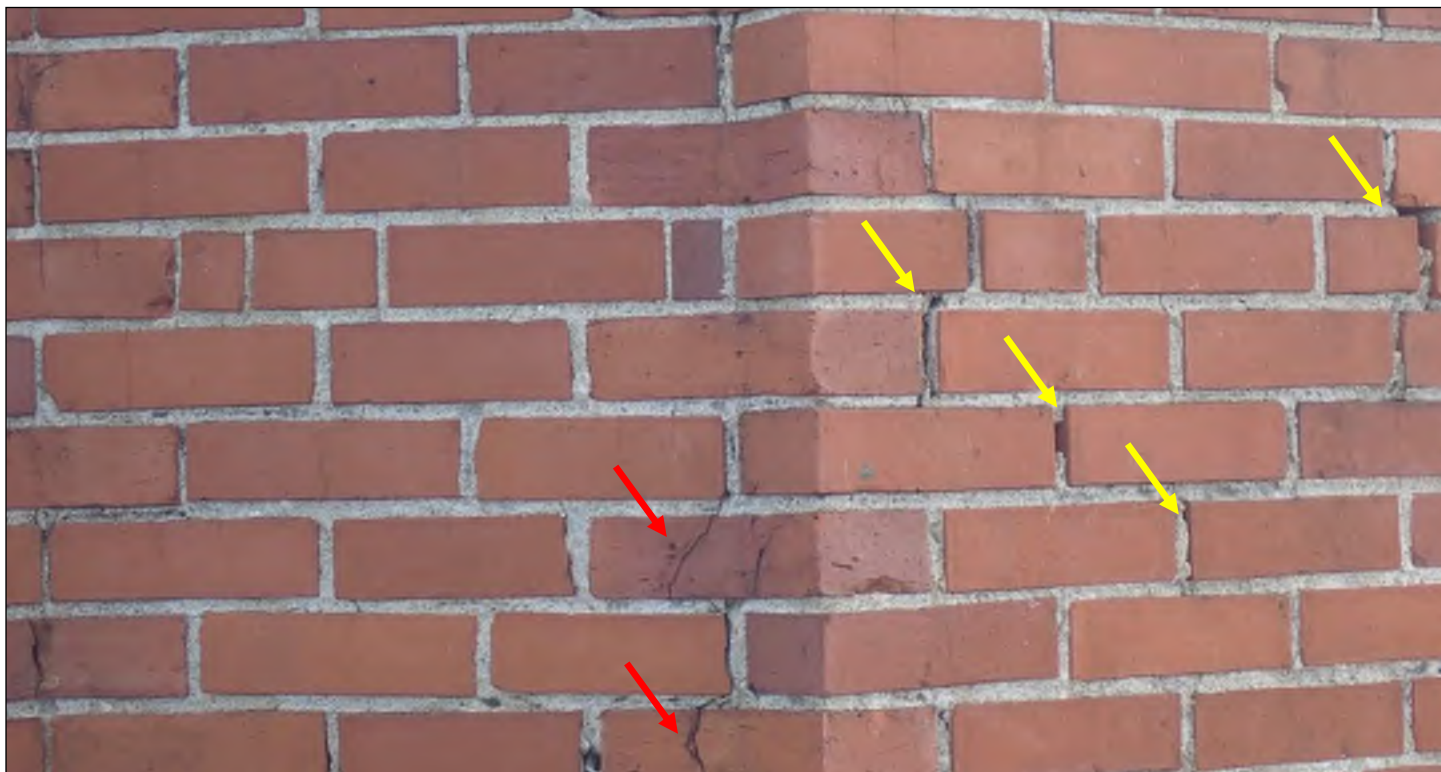
Photo 19: Close-up view of cracks in smokestack brick (red arrows) and mortar joint deterioration (yellow arrows).

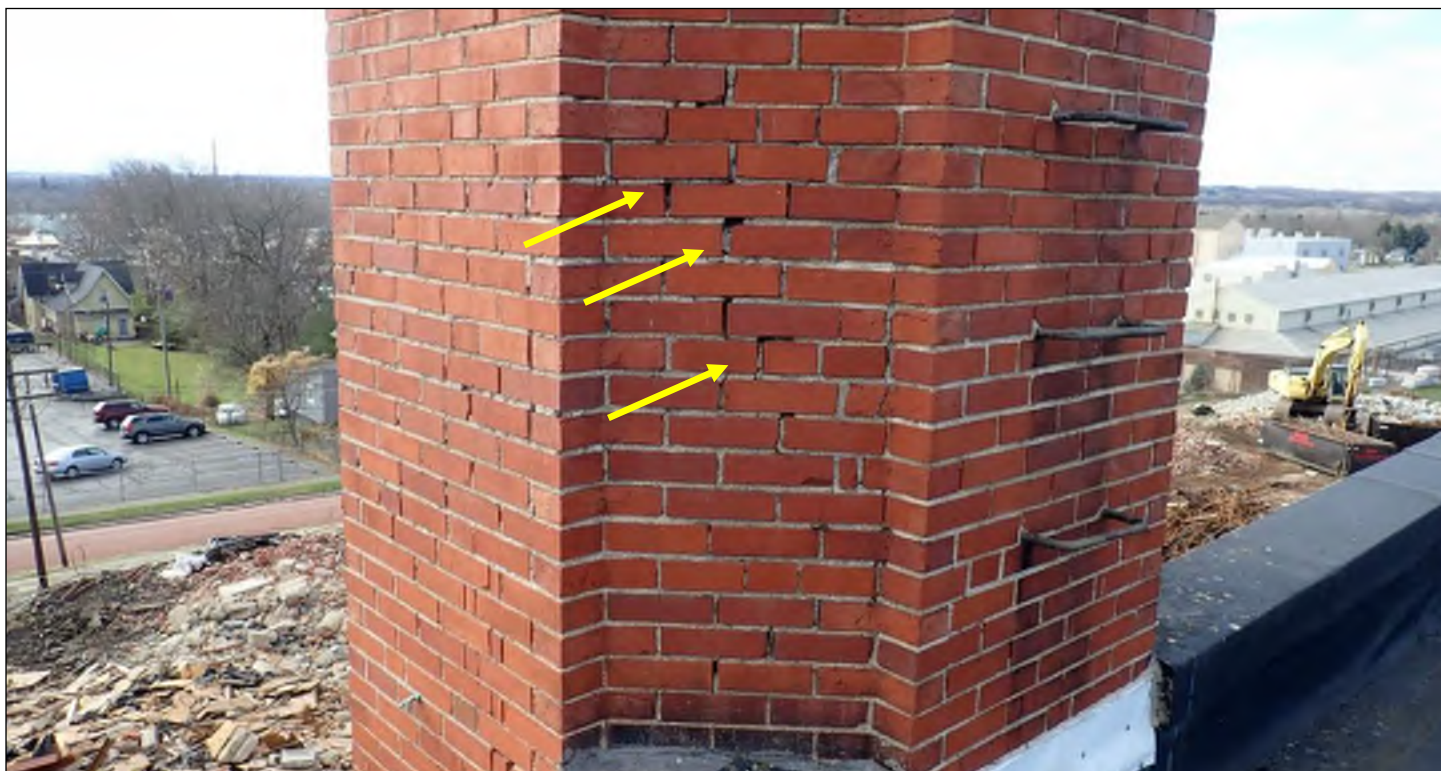
Photo 20: Close-up view of deteriorated mortar joints on smoke stack.

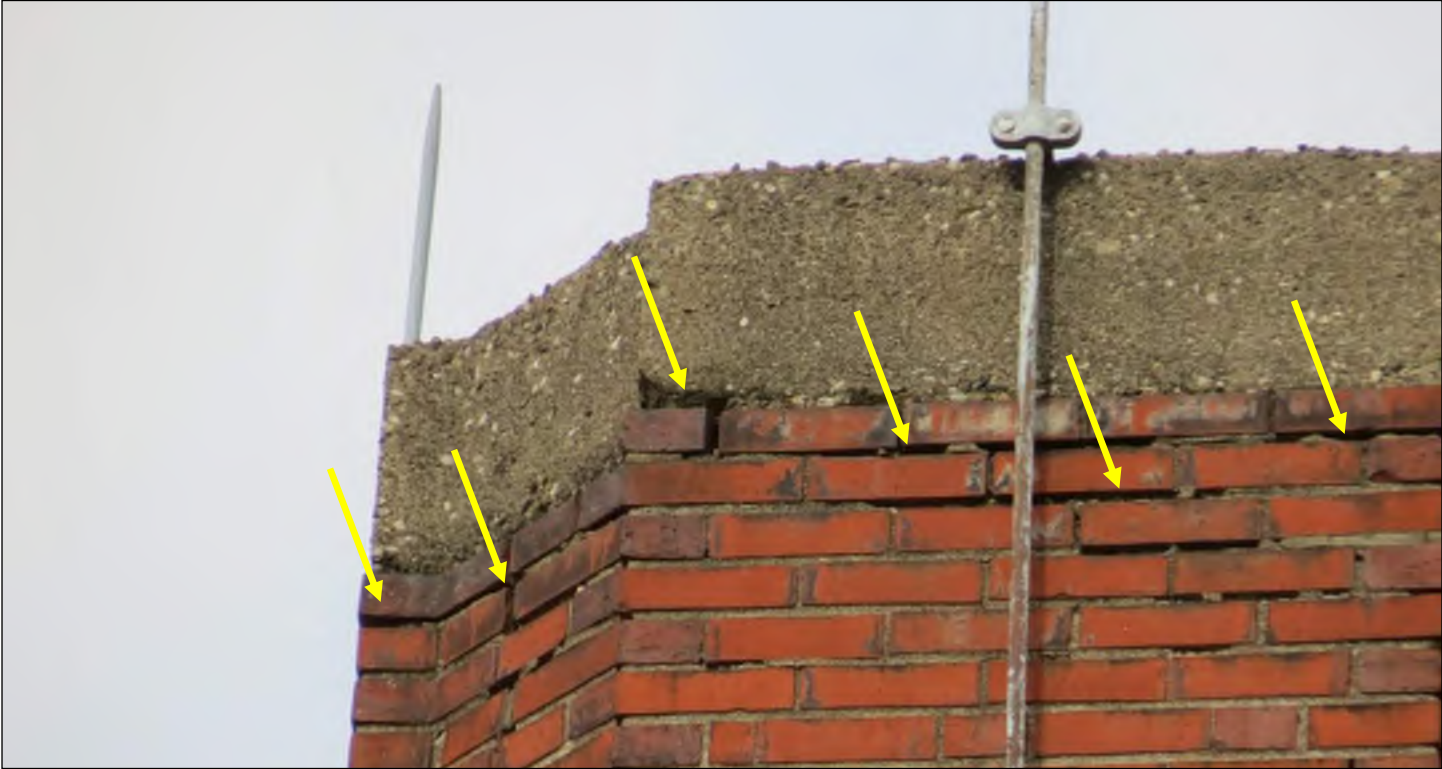
Photo 21: Mortar joint deterioration near smokestack crown.

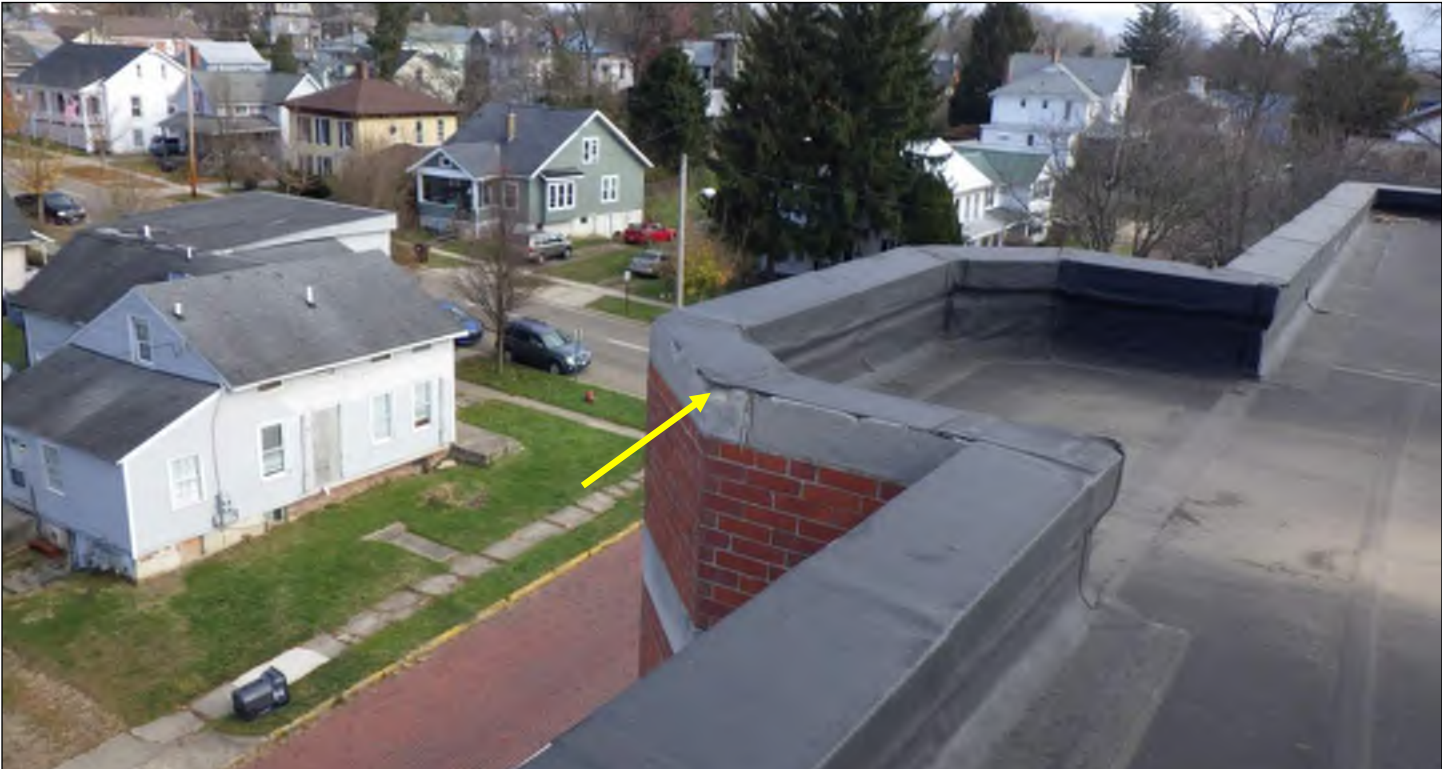
Photo 22: Old spalls on parapet, with dirt buildup on surface.

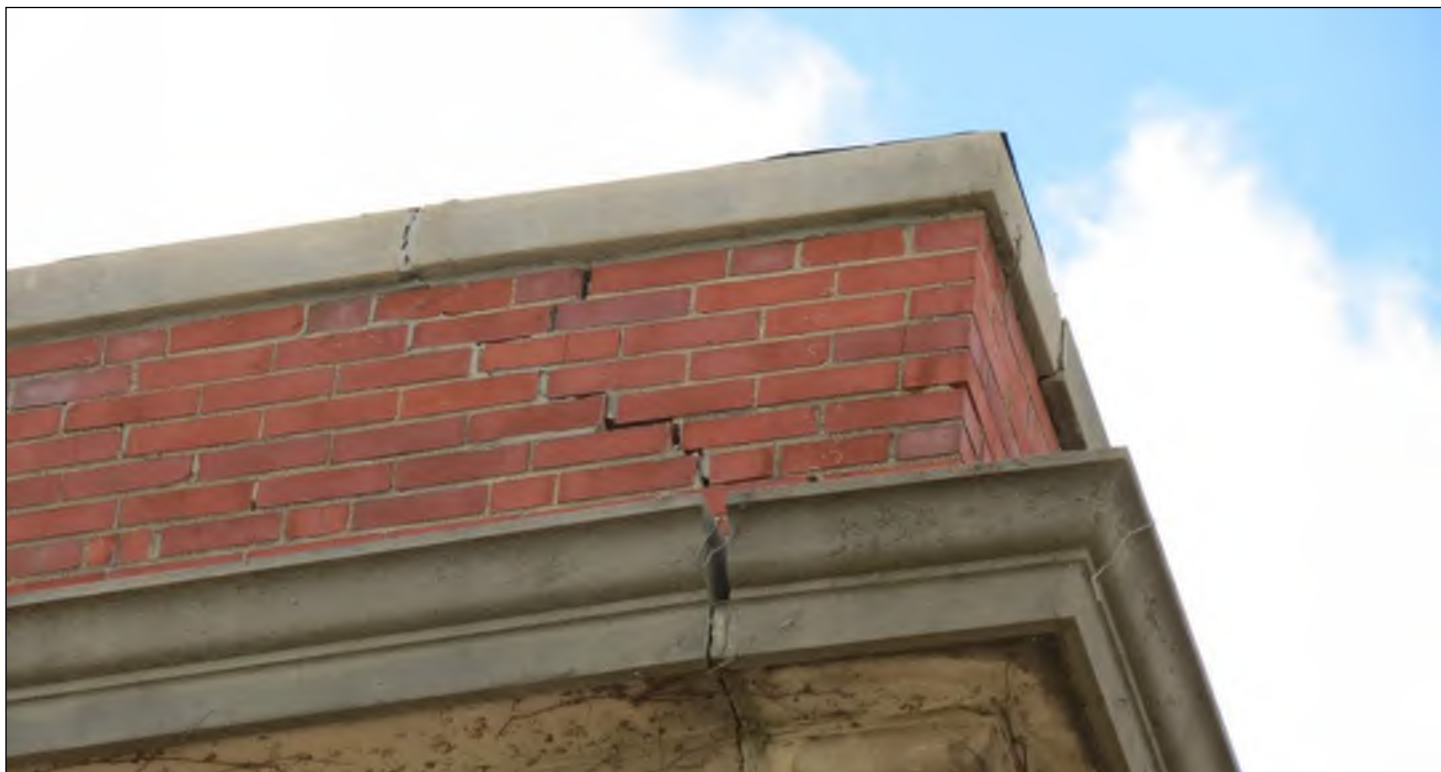
Photo 23: Cracking near parapet corner.

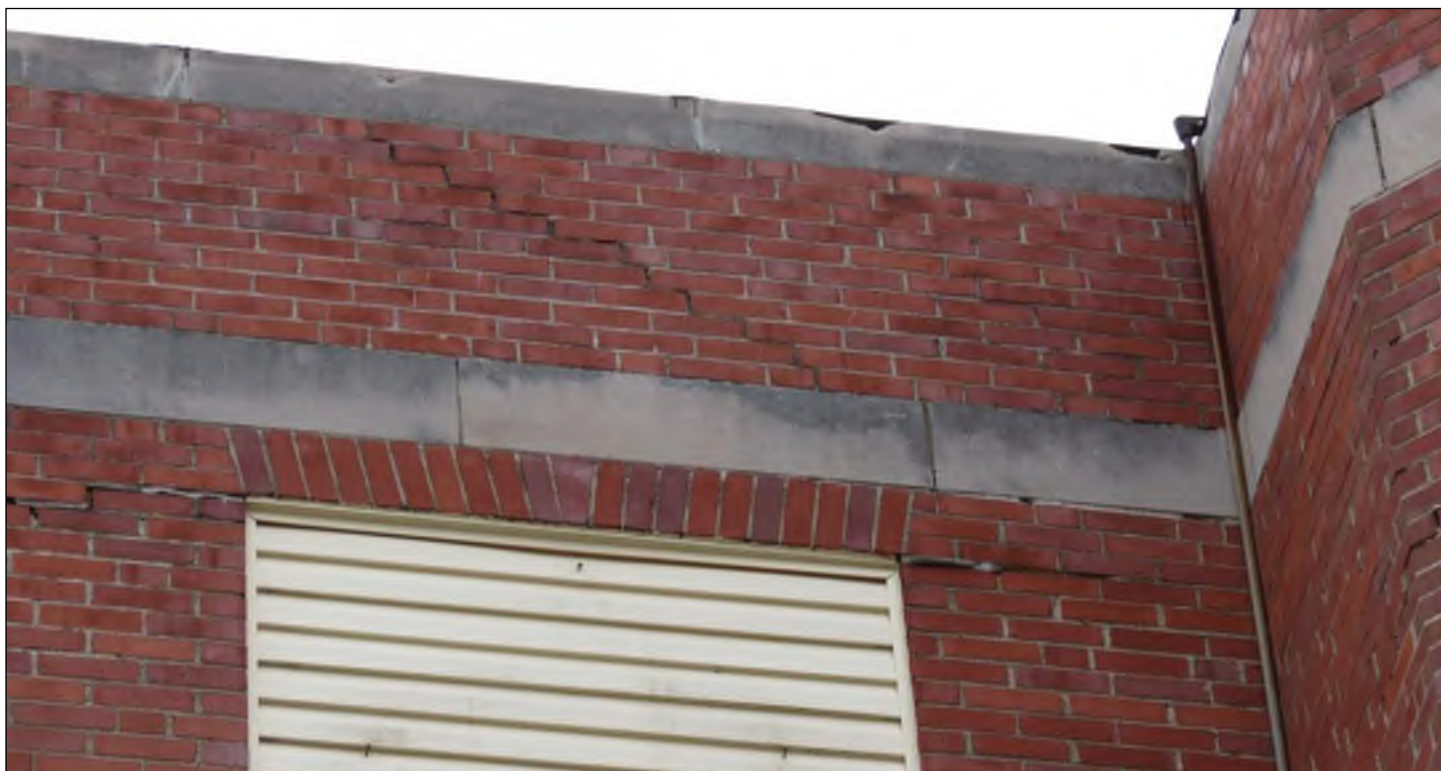
Photo 24: "Stair-step" cracking along parapet mortar joints.

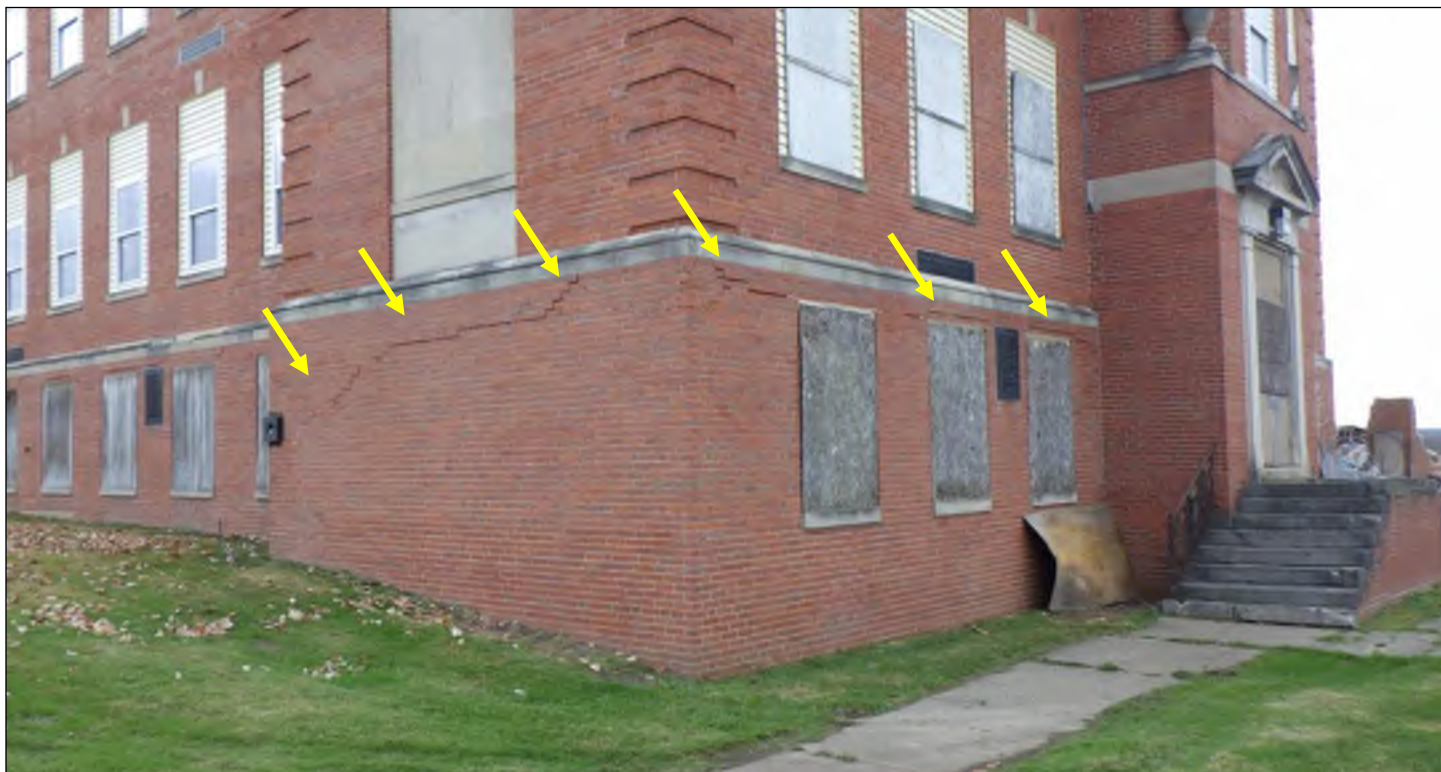
Photo 25: Horizontal and "stair-step" cracking along mortar joints near northeast corner.

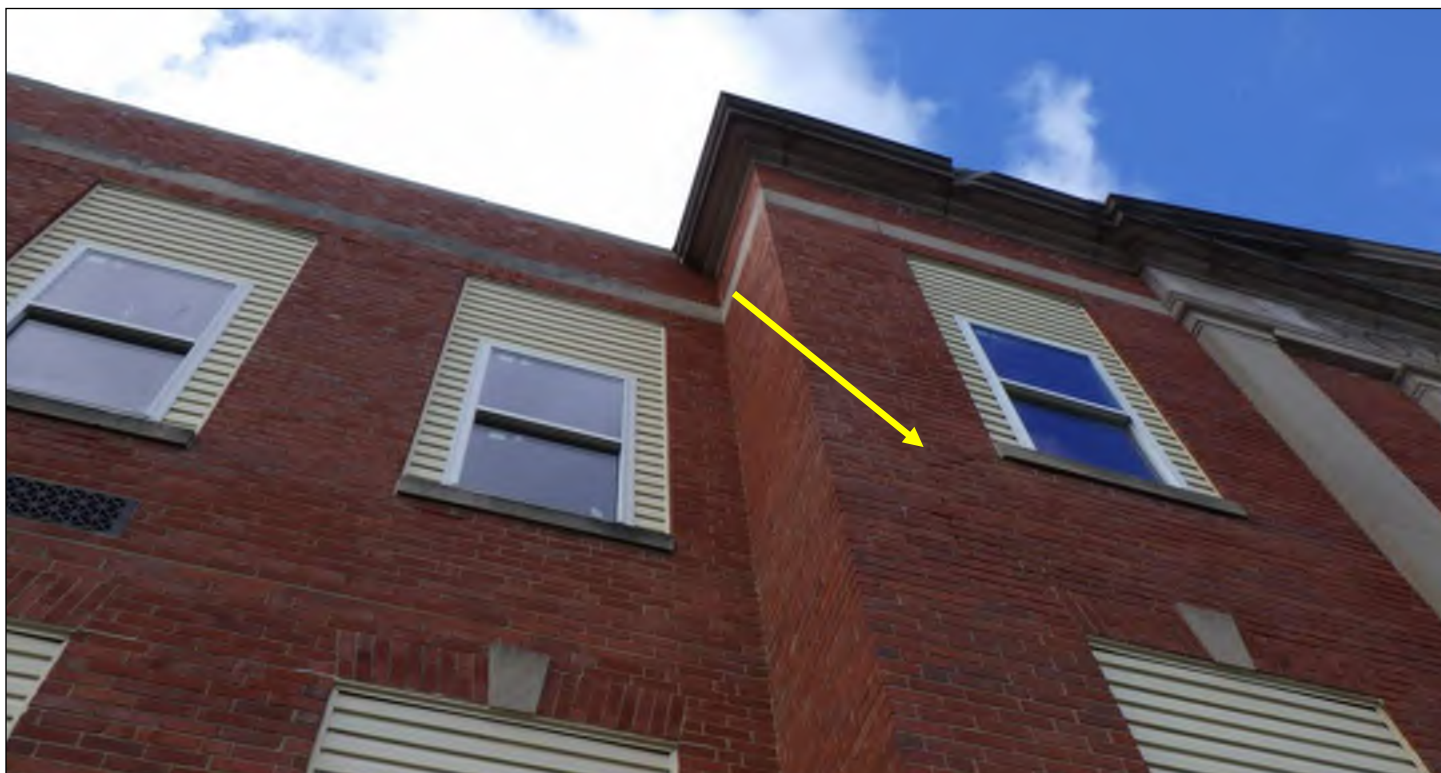
Photo 26: Crack propagating from corner of window opening.

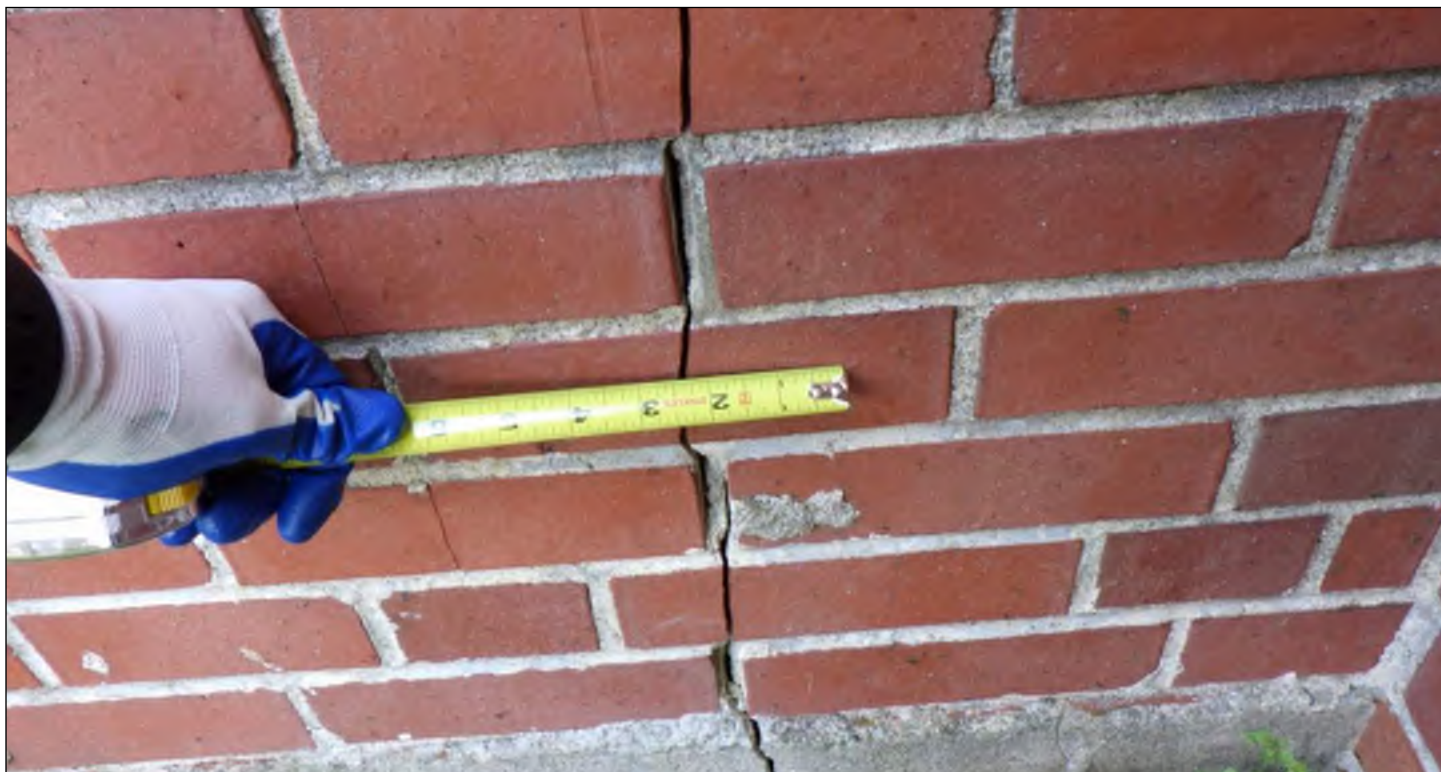
Photo 27: Vertical crack near base of brick masonry bearing wall.

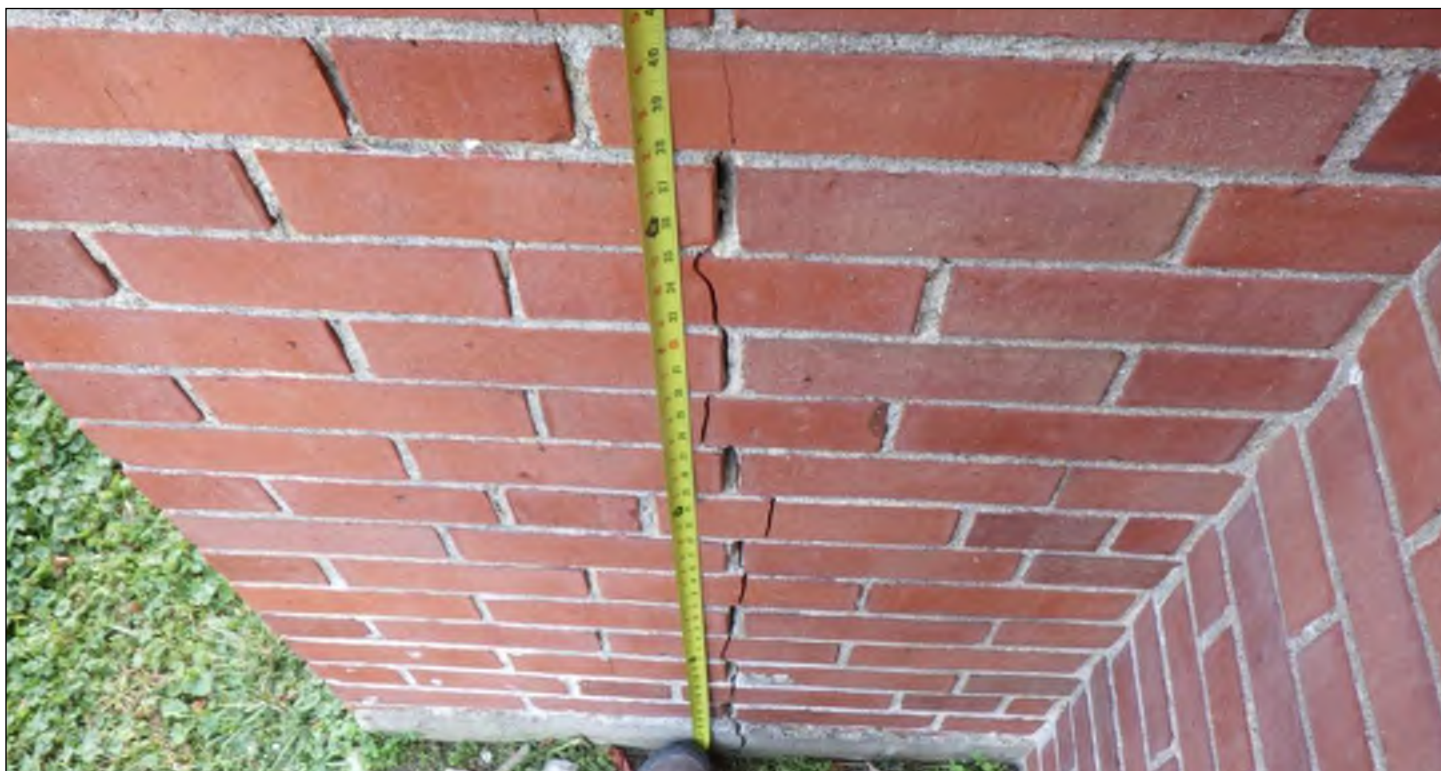
Photo 28: Vertical crack near base of brick masonry bearing wall.

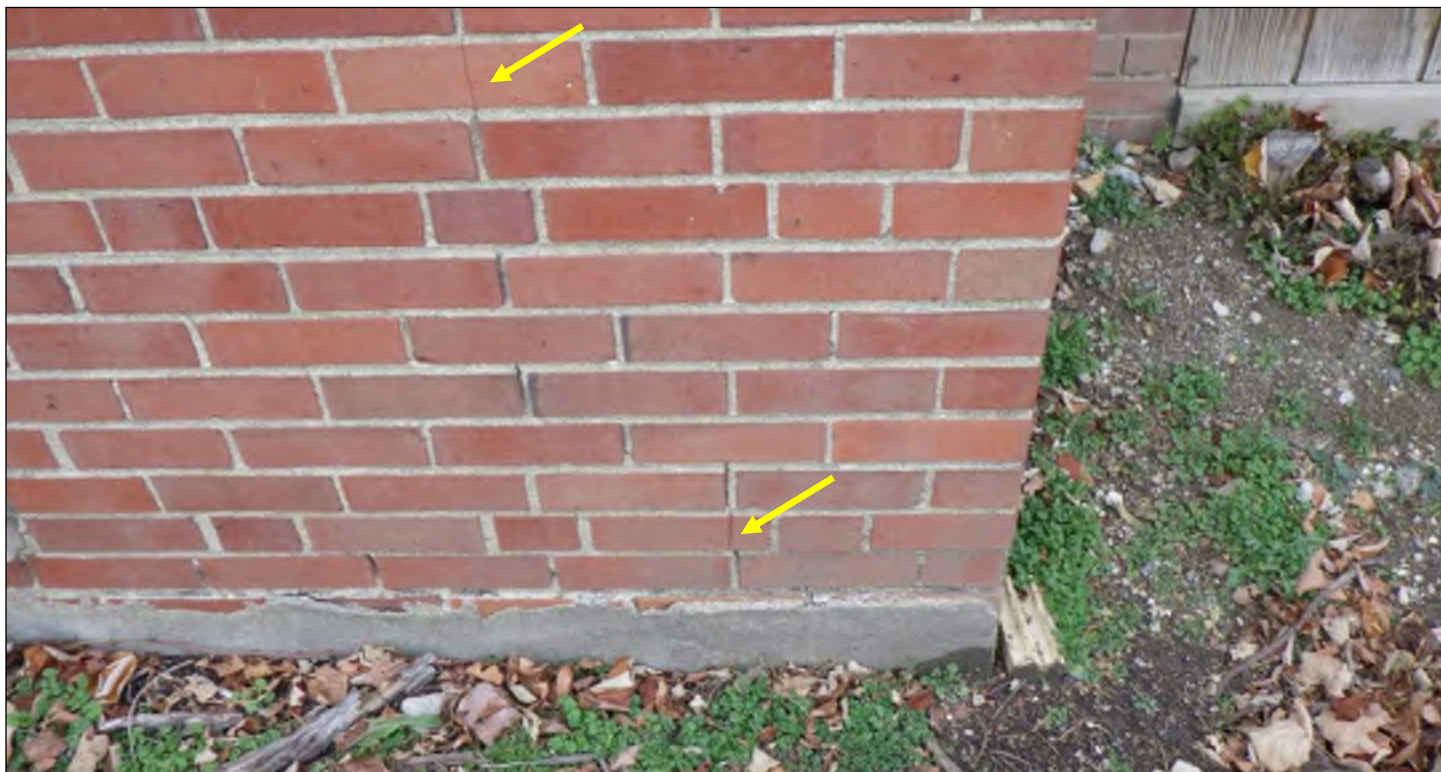
Photo 29: Hairline vertical cracking through brick masonry near base of wall.

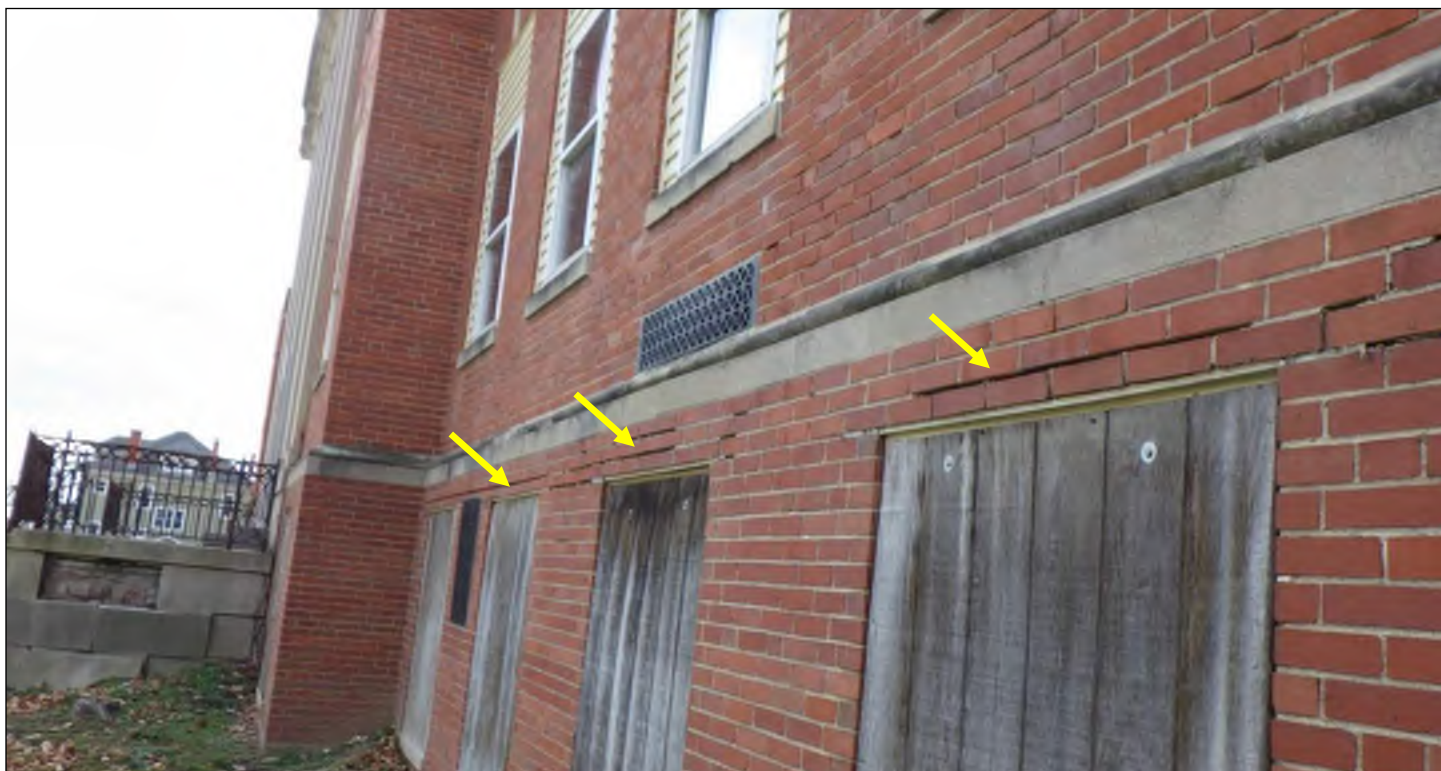
Photo 30: Horizontal cracking and missing or degraded mortar in brick above window openings.

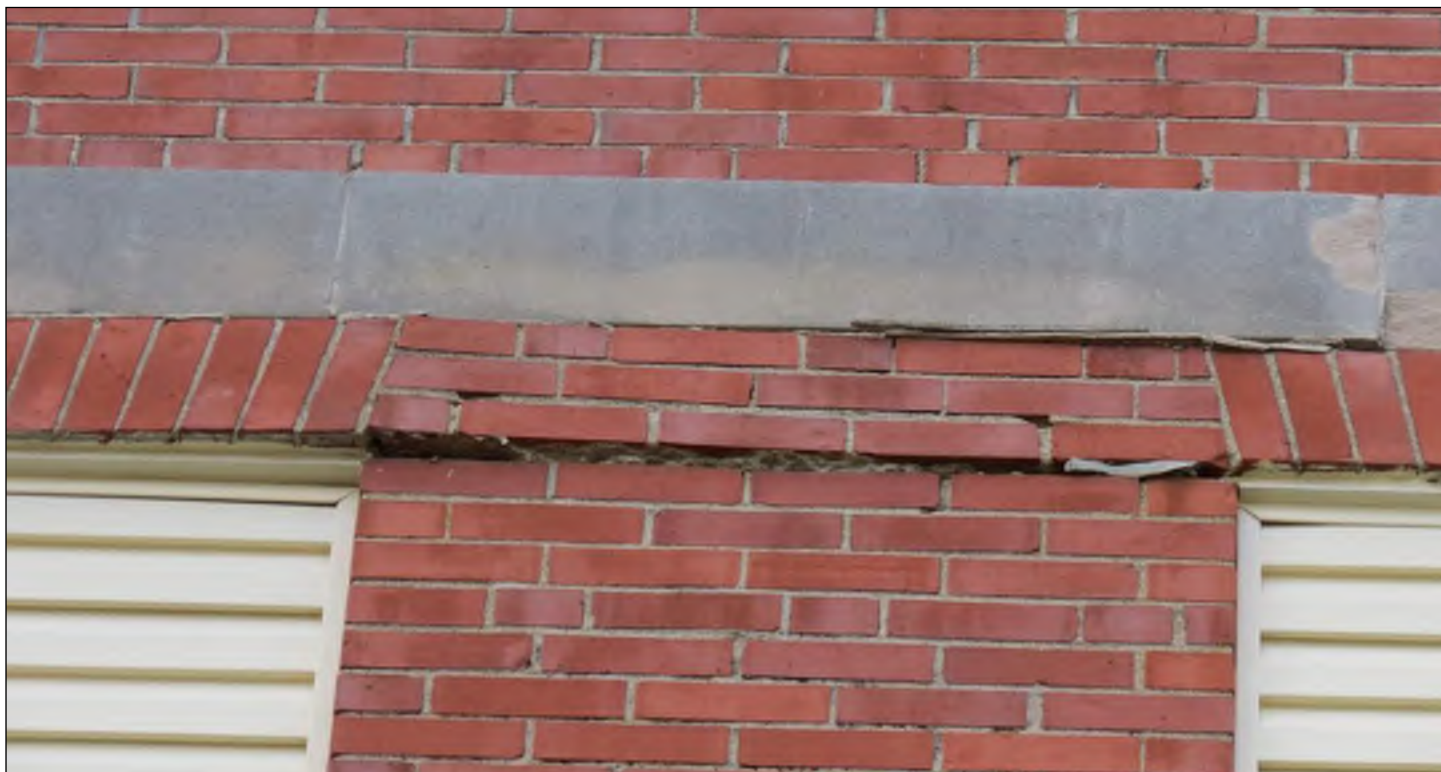
Photo 31: Horizontal cracking and missing or degraded mortar in brick above window openings.

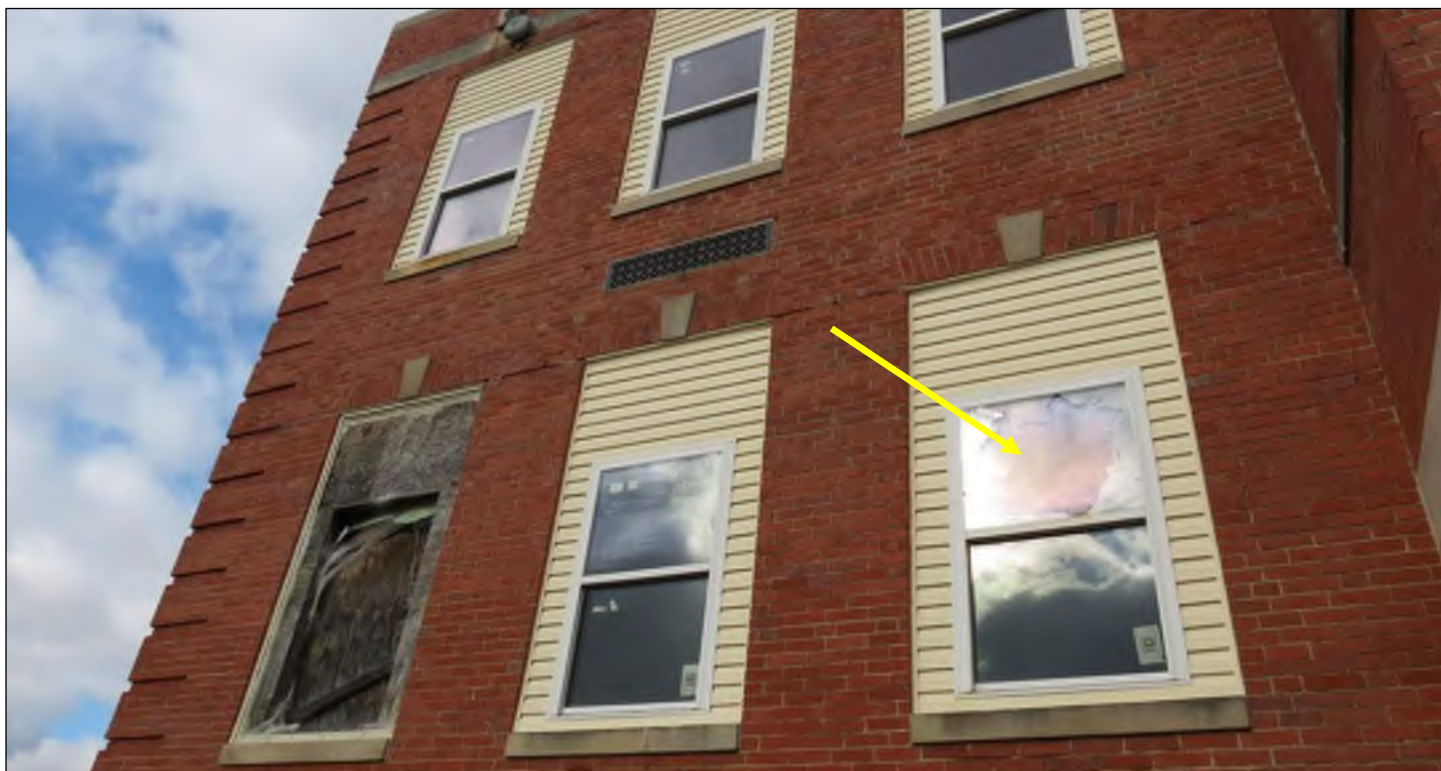
Photo 32: Broken window.

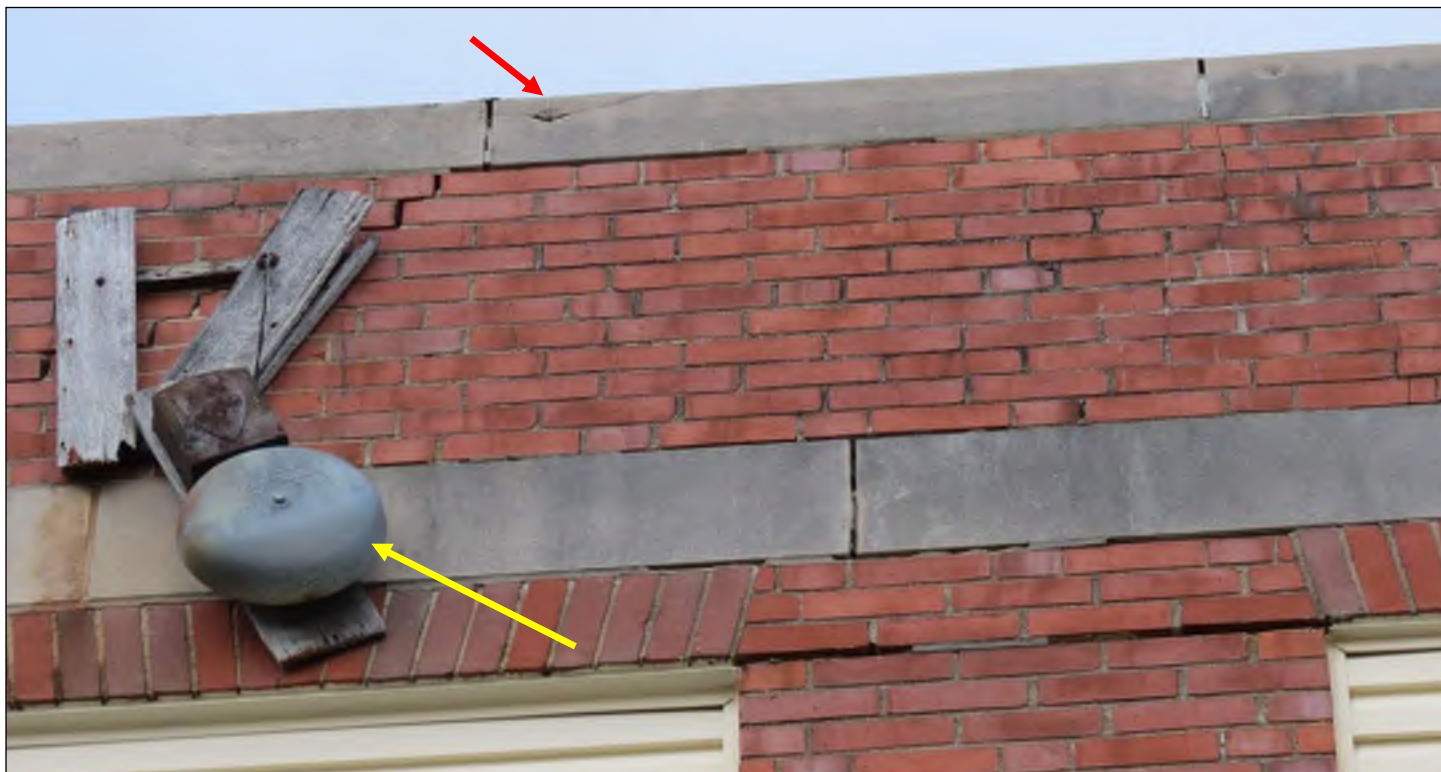
Photo 33: Cracks in parapet coping (red arrow). Note the missing or degraded mortar above and below the limestone band and brick above the windows. Old alarm bell suspended by electrical cable (yellow arrow).

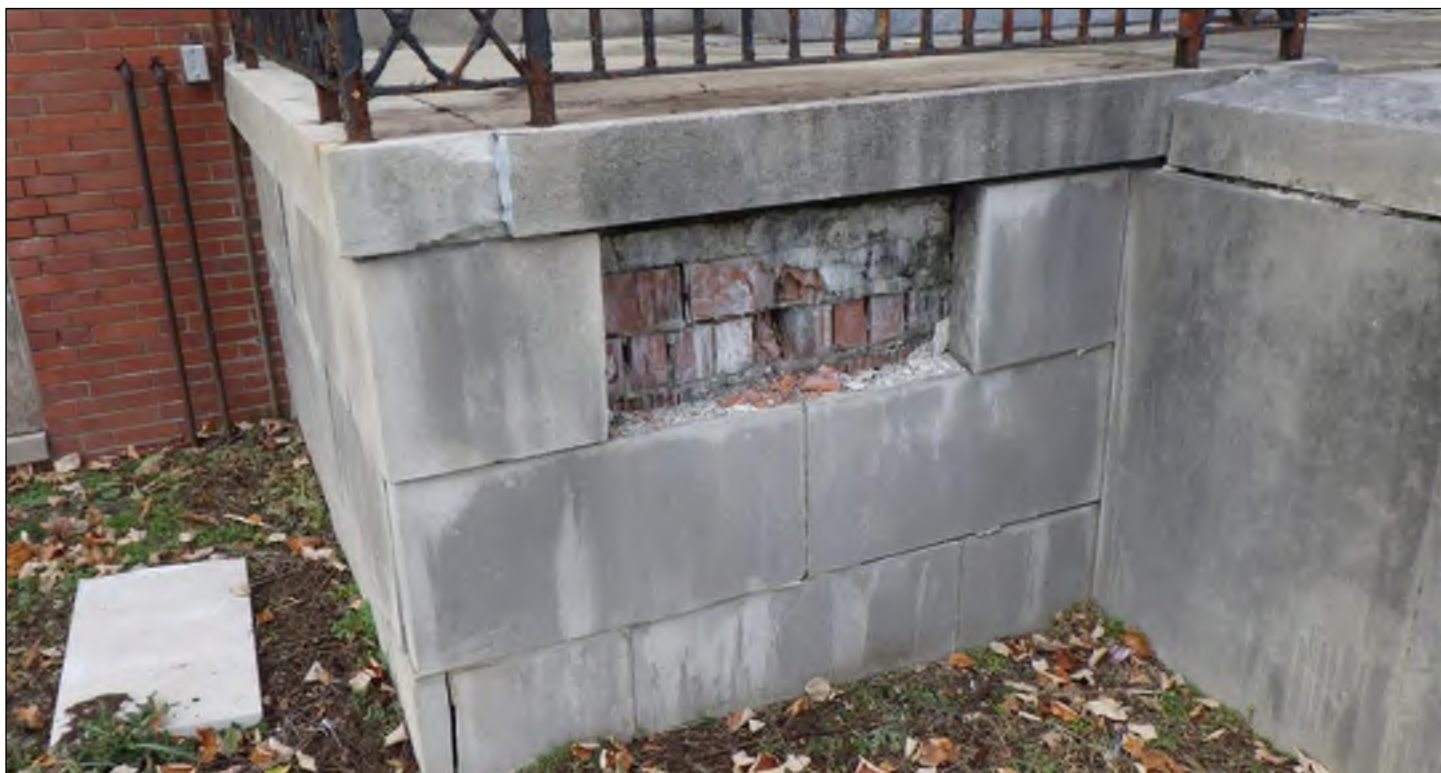
Photo 34: Missing stone block from exterior stairs by east entrance.

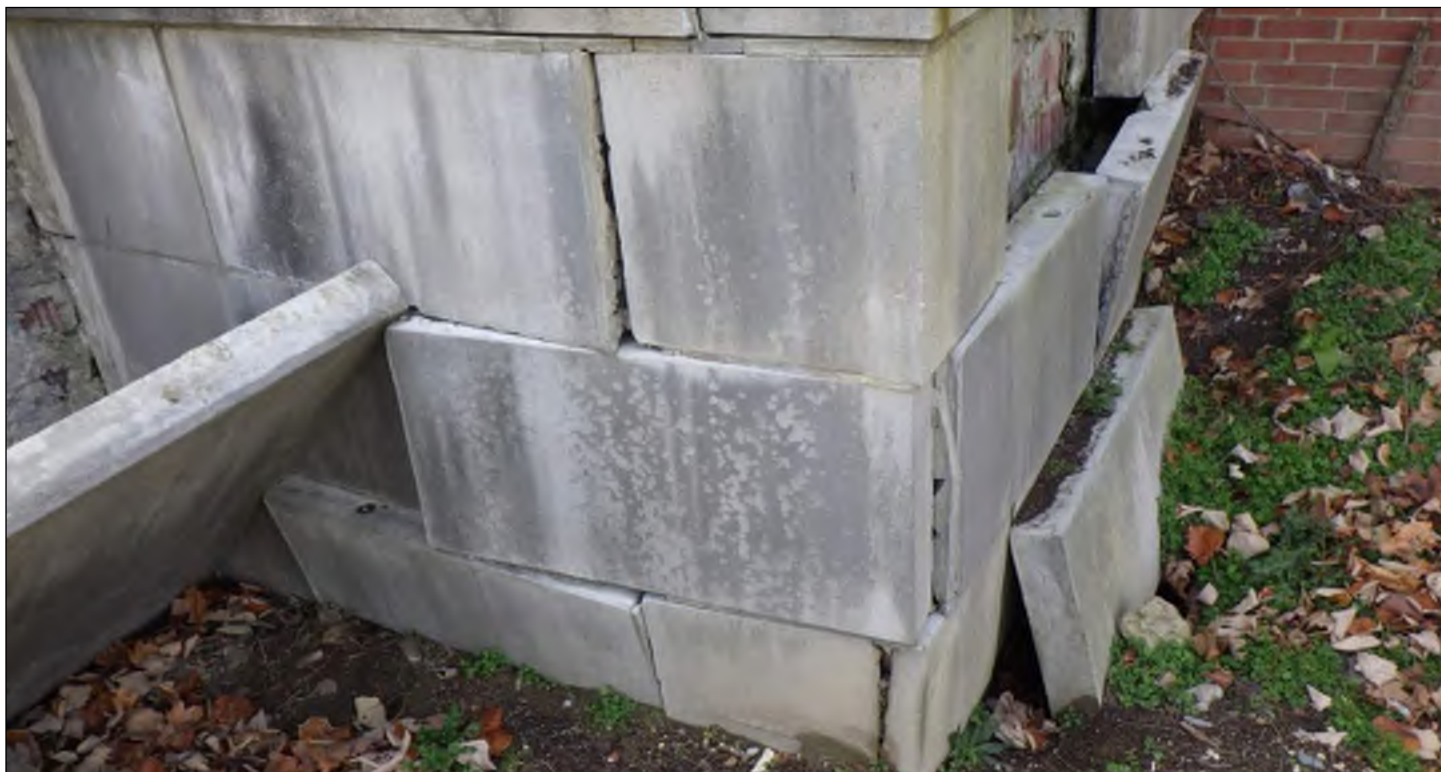
Photo 35: Loose stone blocks at stairs by east entrance.

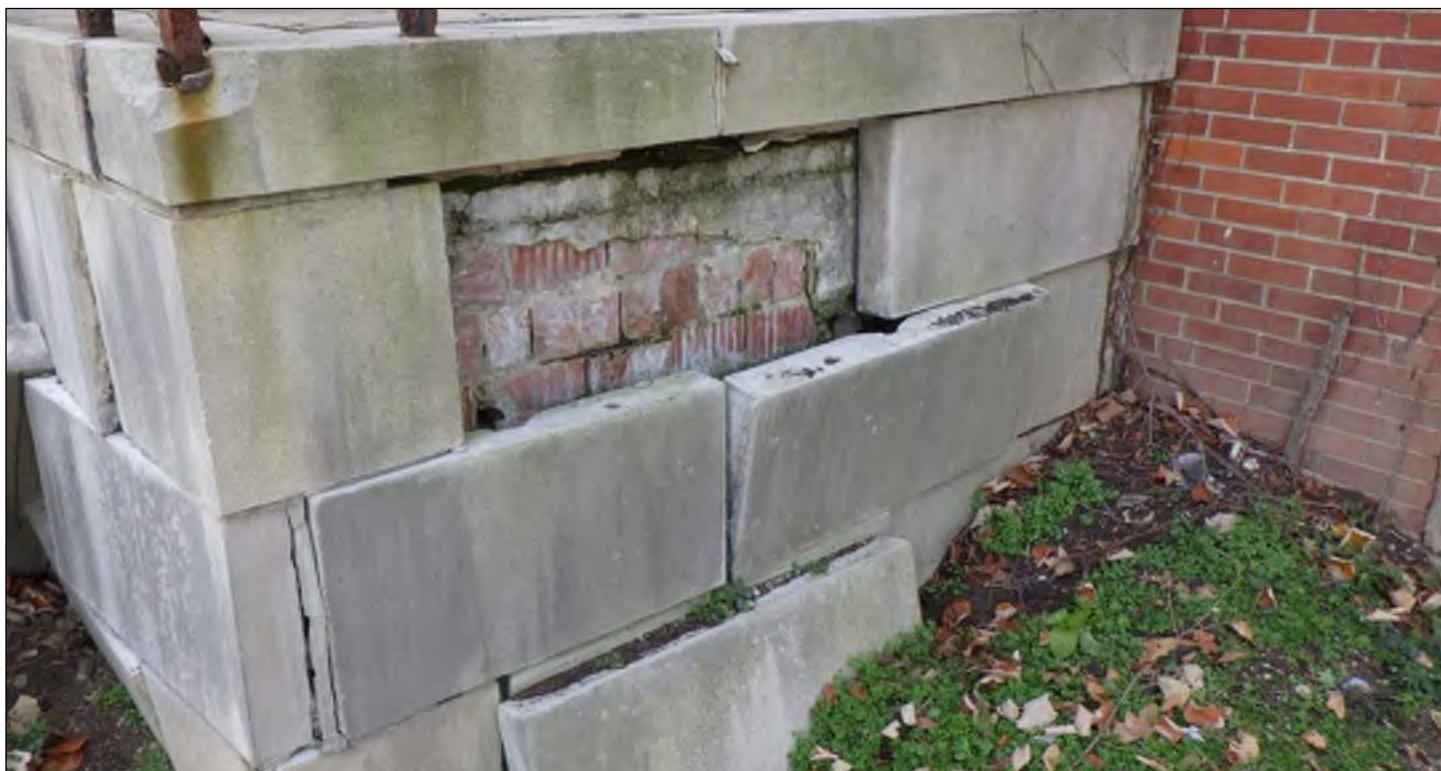
Photo 36: Bricks with missing mortar at exterior stairs by east entrance.

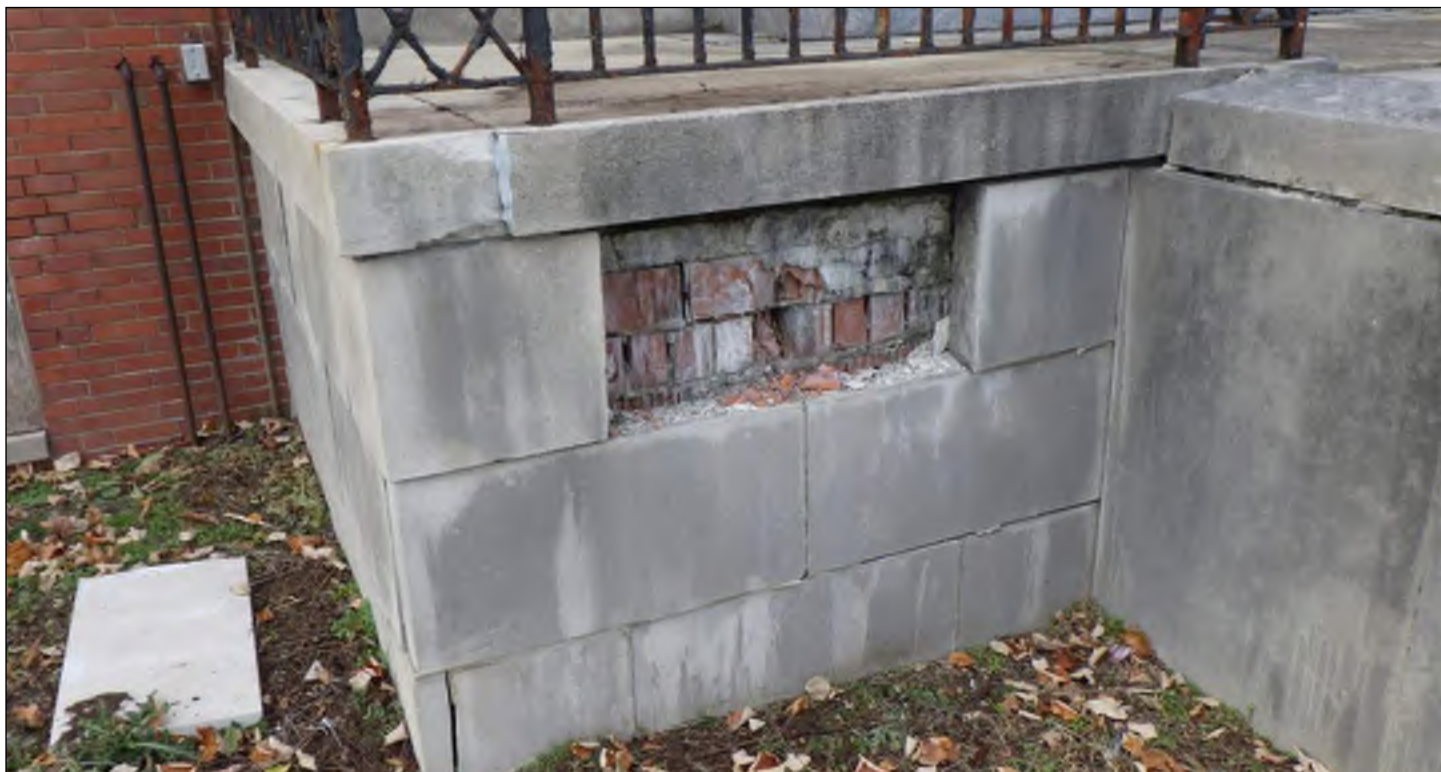
Photo 37: Cracked/spalled bricks at exterior stairs by east entrance.
