**Board of Property Maintenance Appeals
Board Meeting**

**February 11, 2021
5:30 PM**

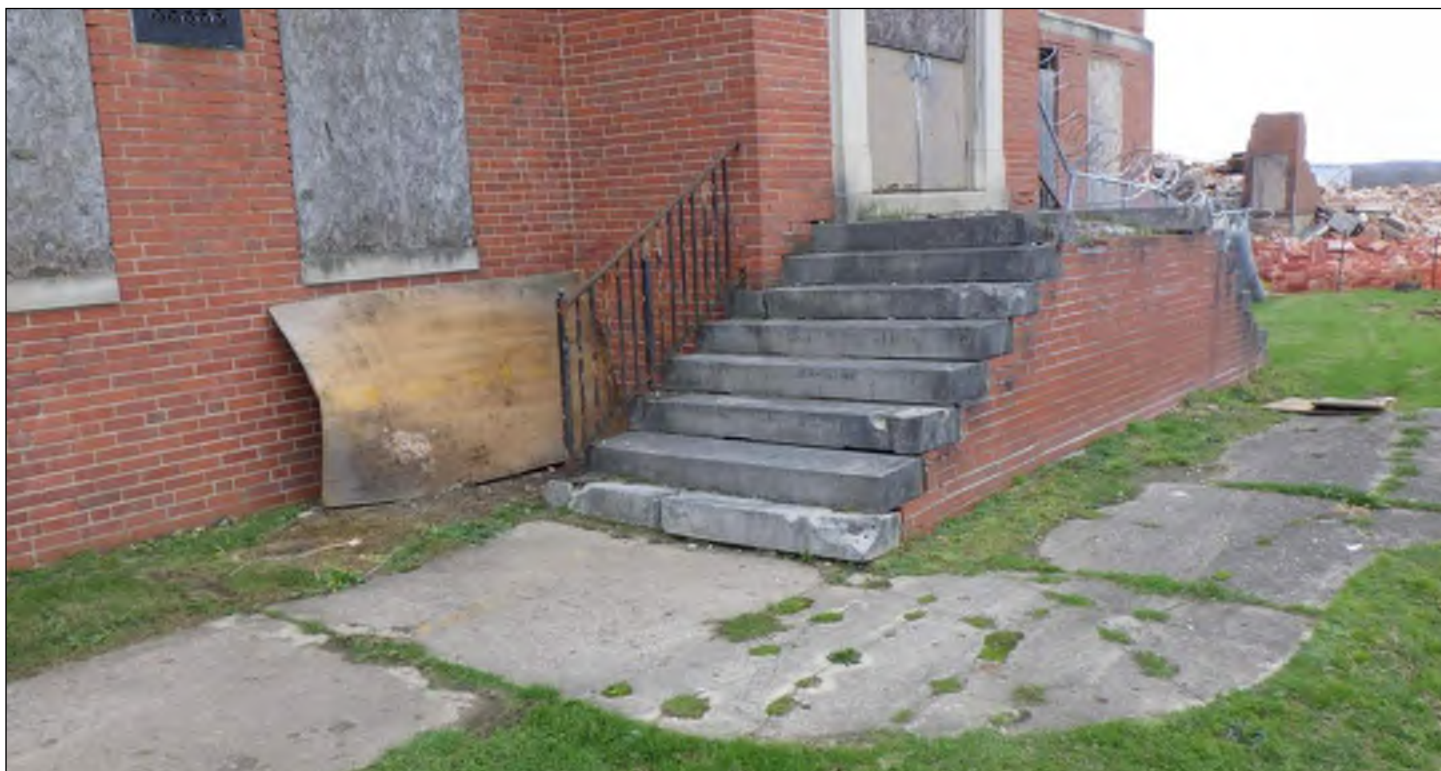
Photo 38: Exterior stairs by north entrance. Note the lack of finished walking surface and handrails.

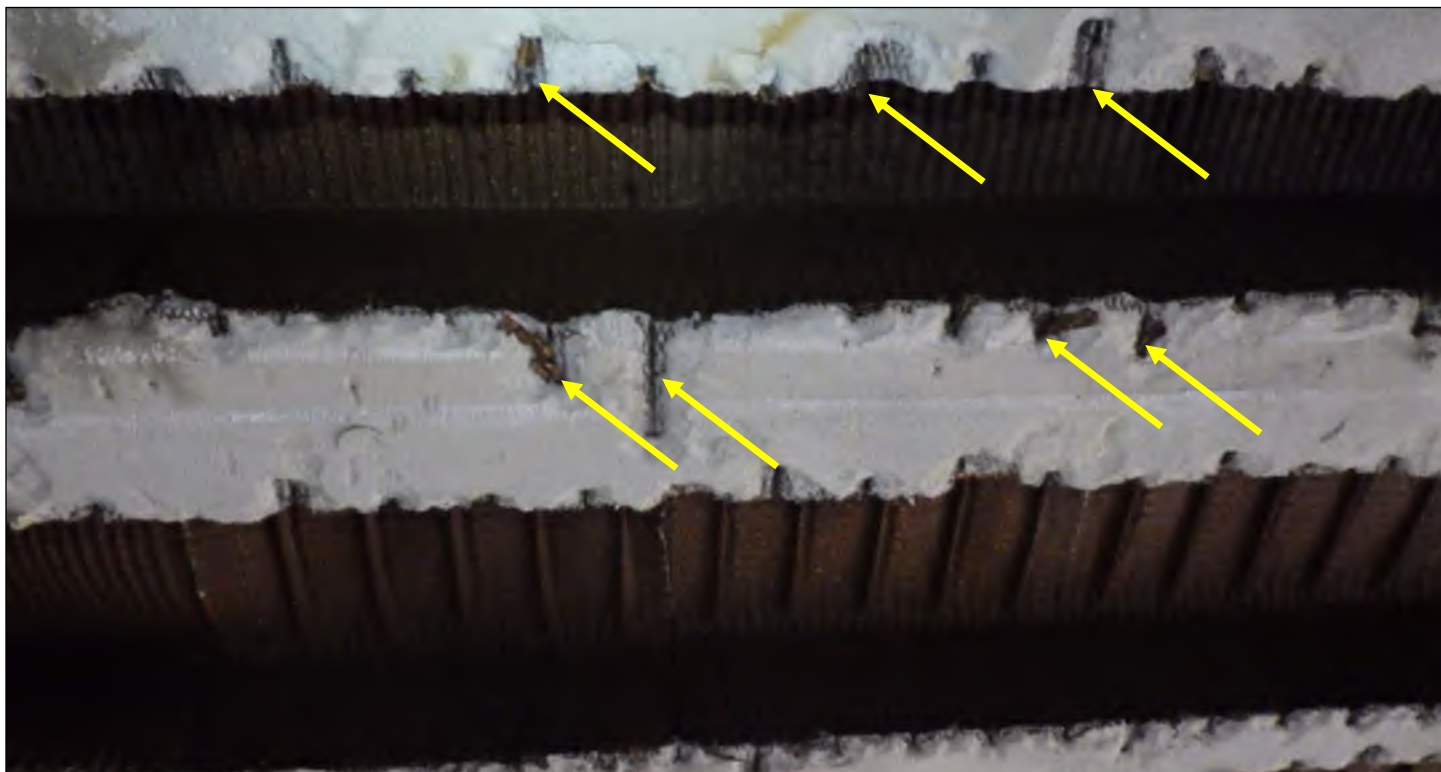
Photo 43: Plaster at the underside of concrete joists. Note rusty ribbed lath (arrows).

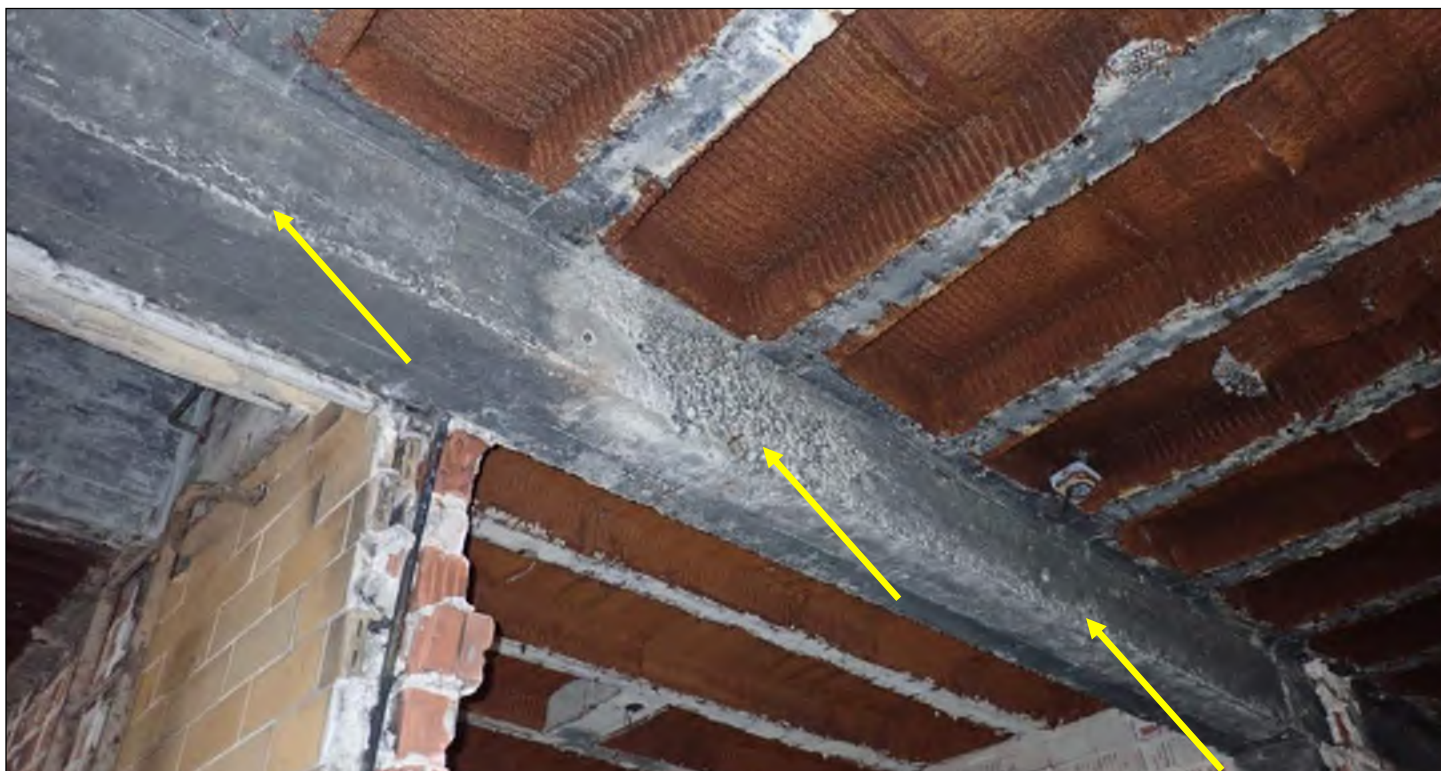
Photo 44: Honeycombing on a reinforced concrete beam (arrows).

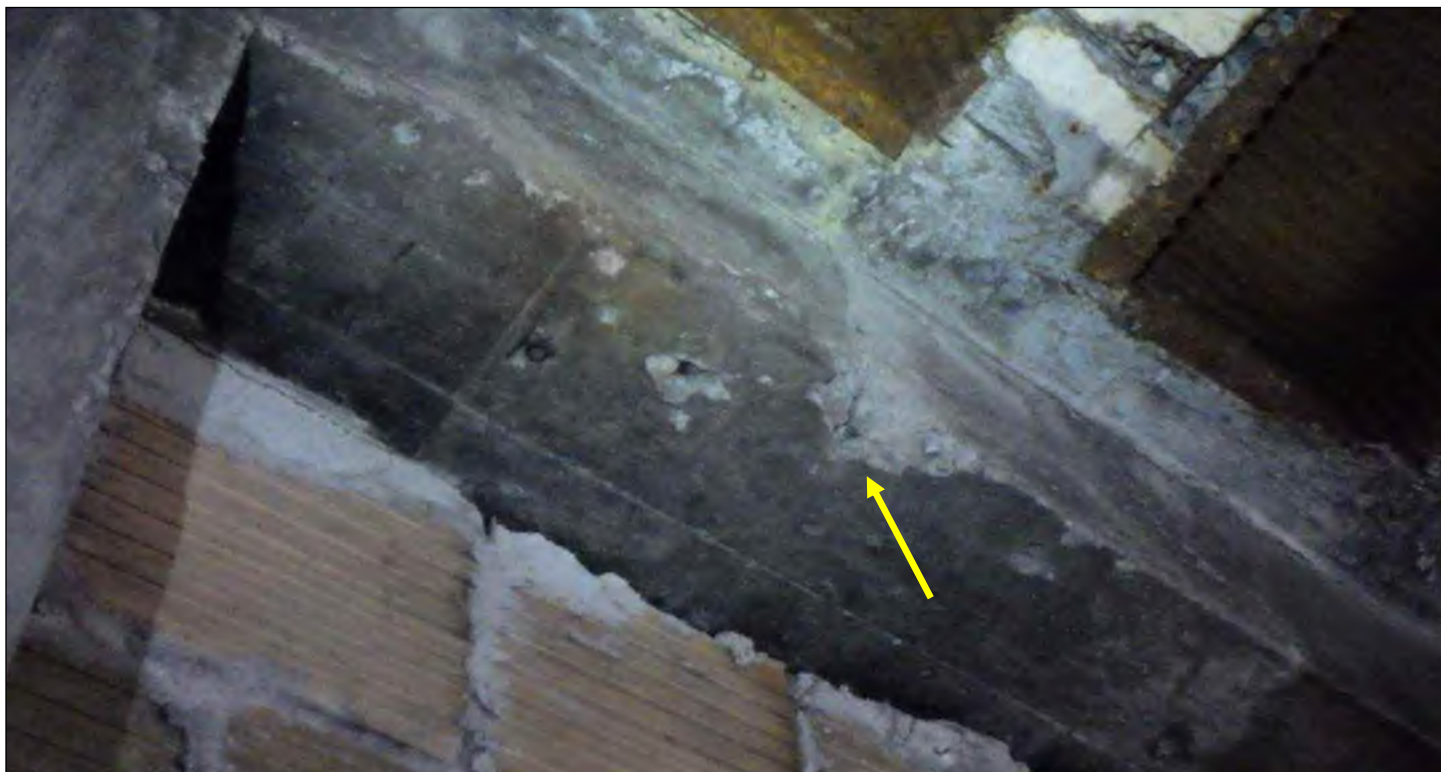
Photo 45: Large missing section of concrete from corner of a beam.

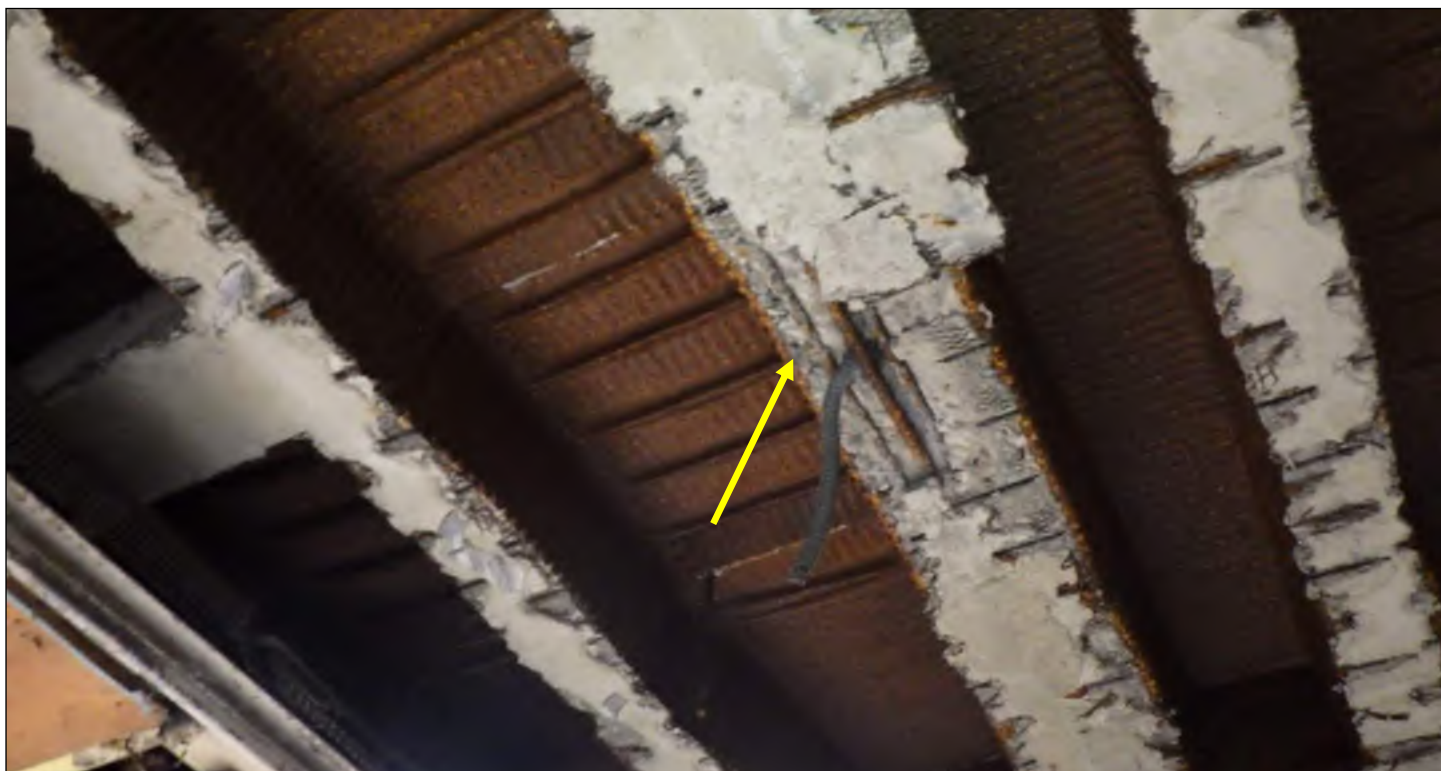
Photo 46: Exposed corroded internal steel reinforcement at a joist (arrow).

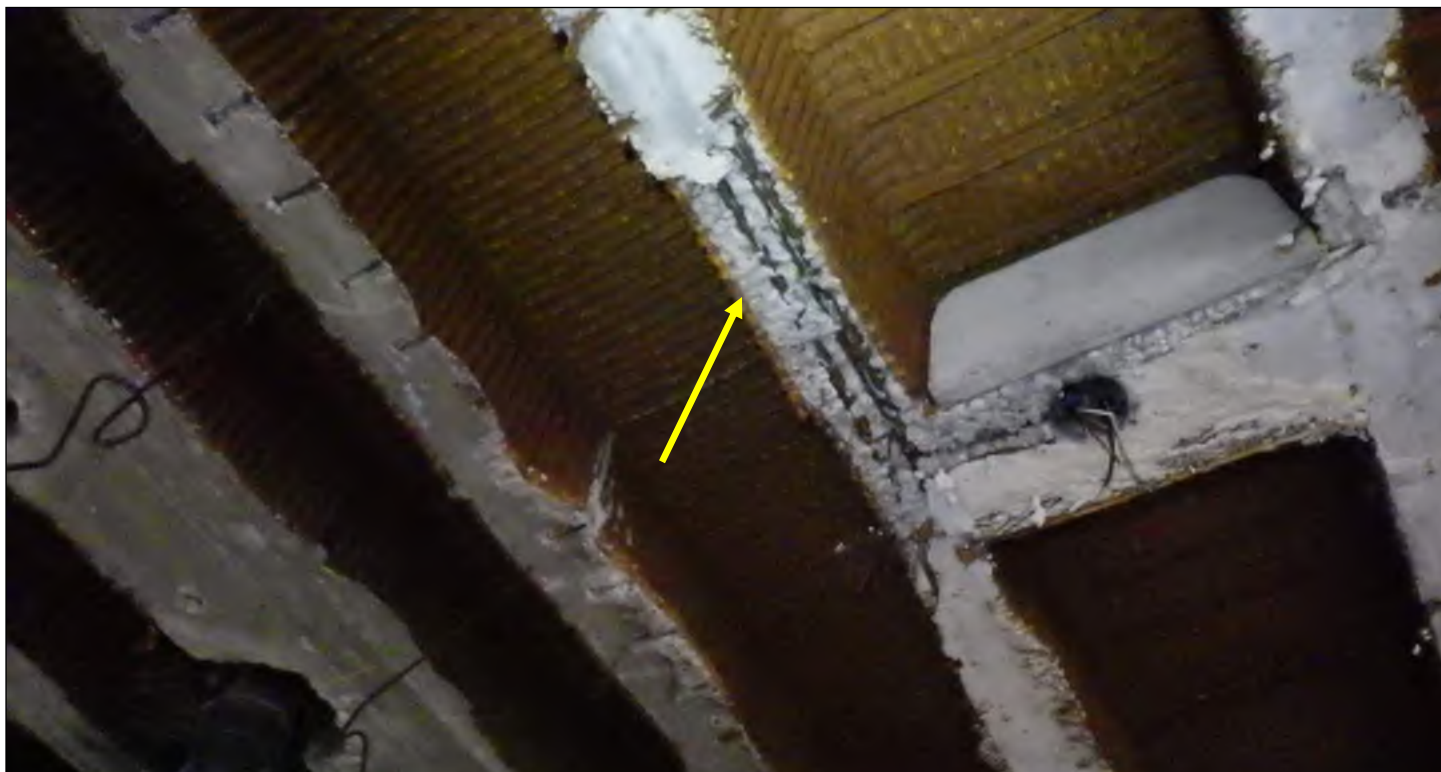
Photo 47: Exposed corroded internal steel reinforcement at a joist (arrow).

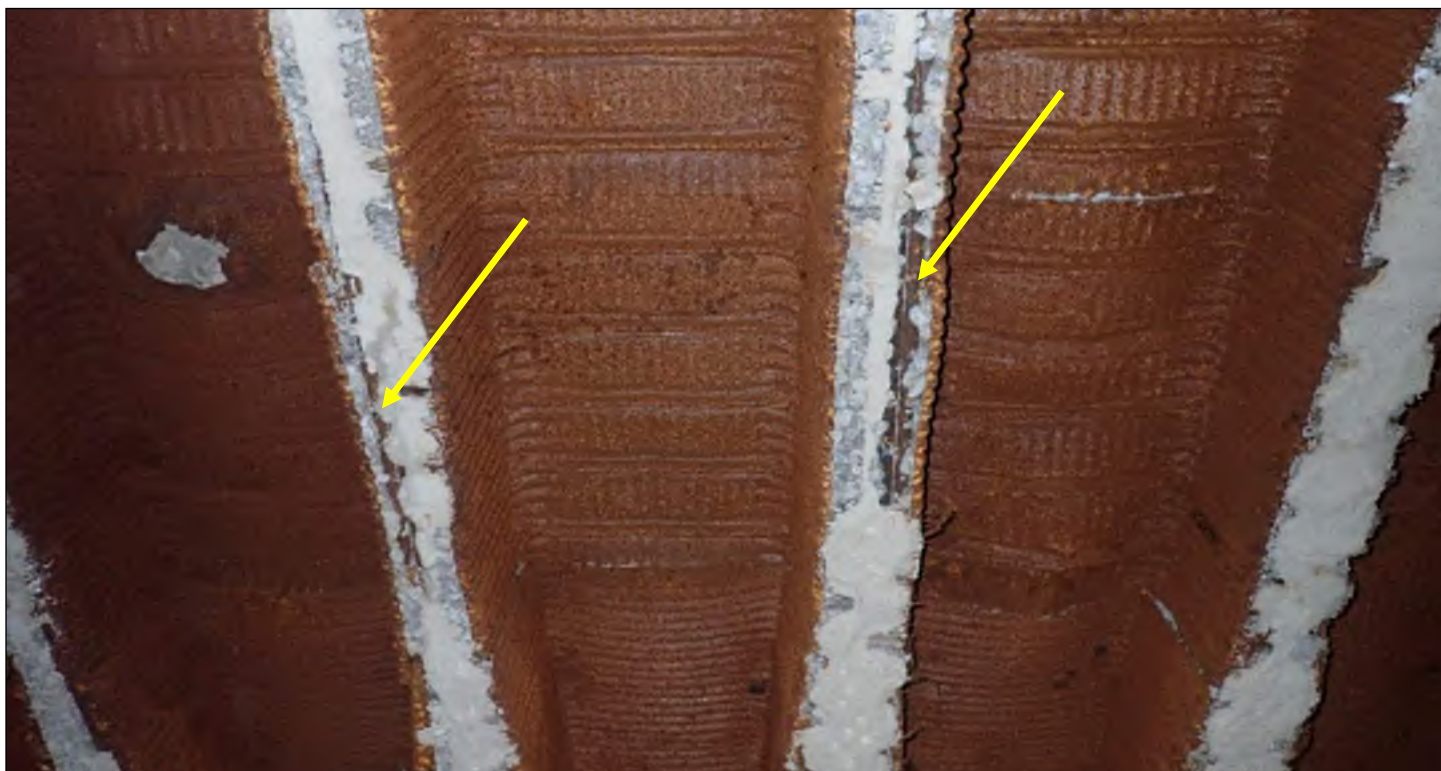
Photo 48: Exposed corroded internal steel reinforcement at joists (arrows).

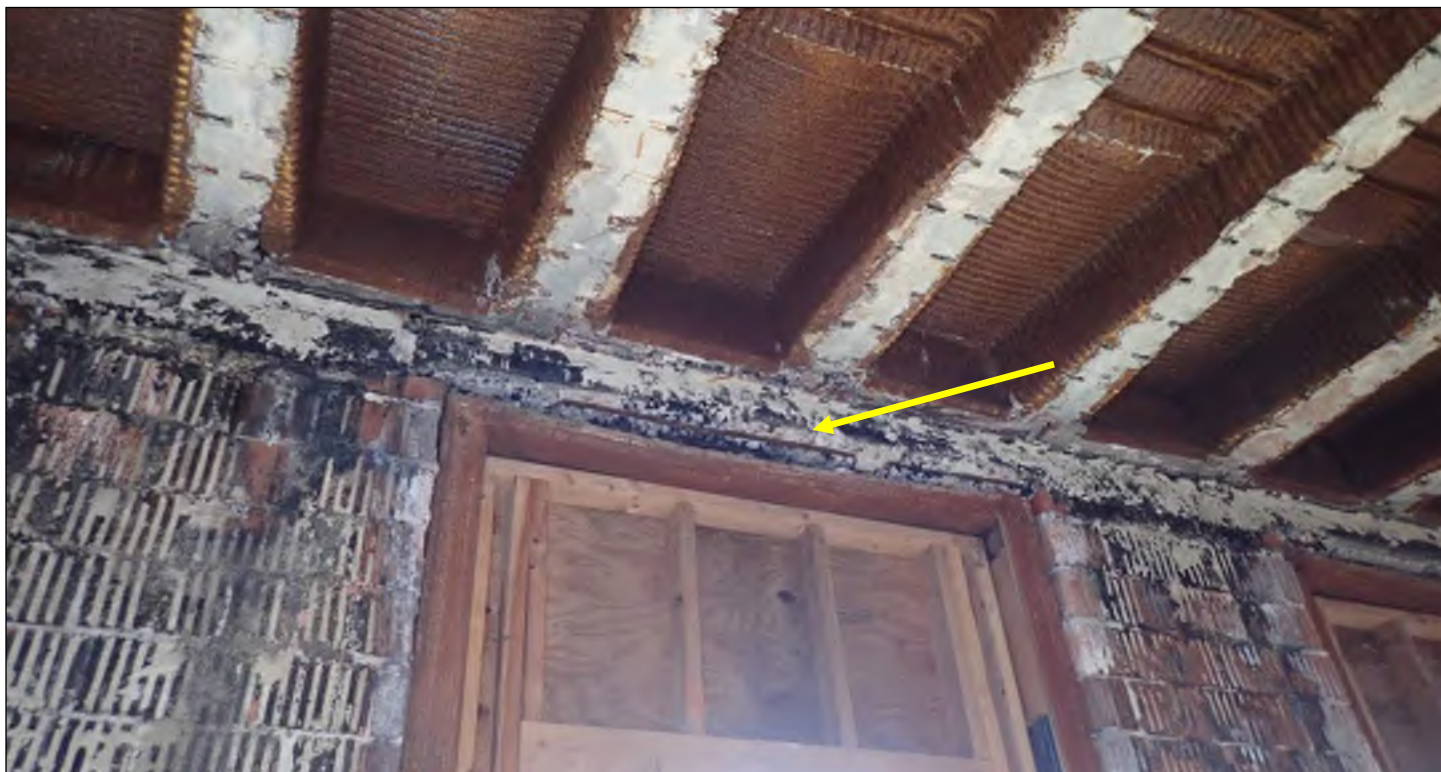
Photo 49: Exposed corroded internal steel reinforcement at a lintel (arrow).

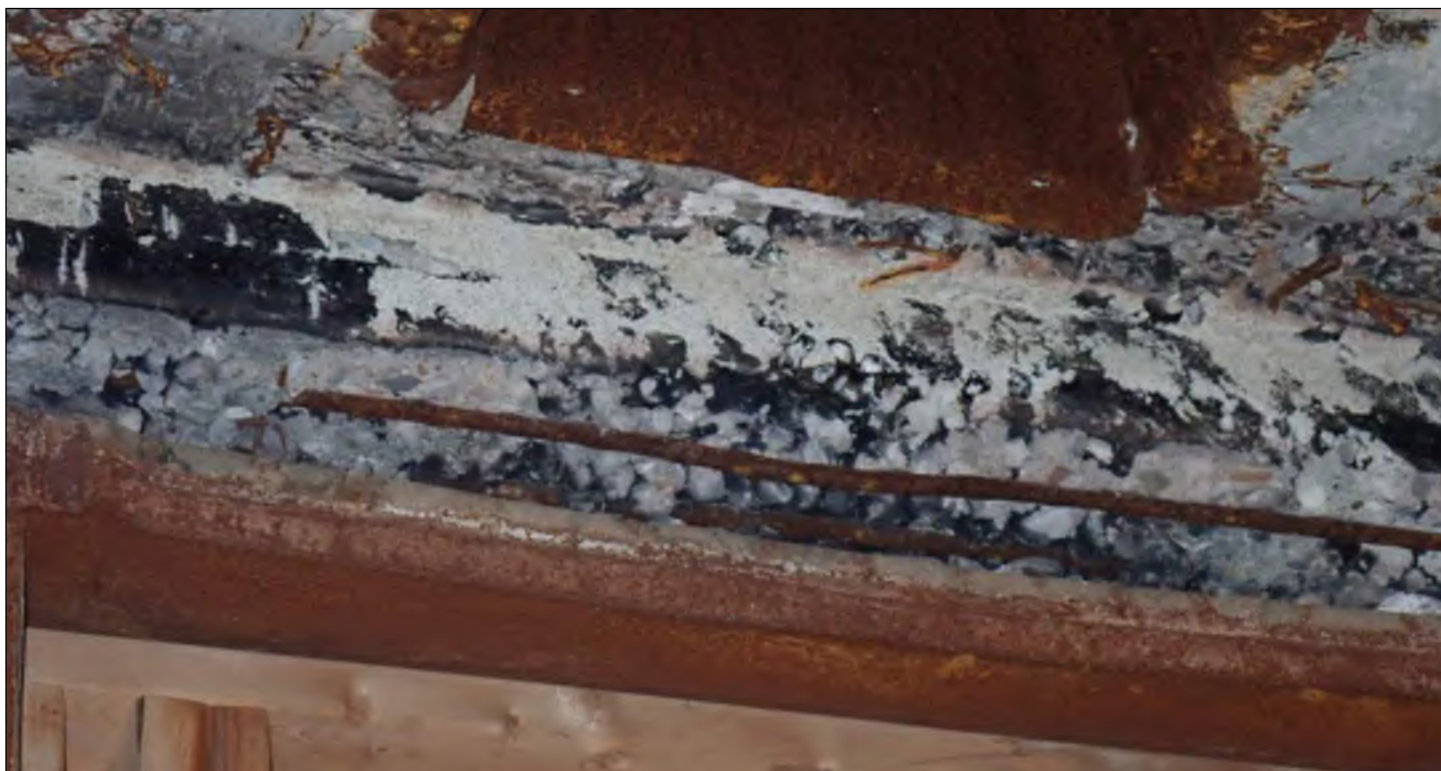
Photo 50: Close-up view of exposed corroded reinforcement at a lintel.

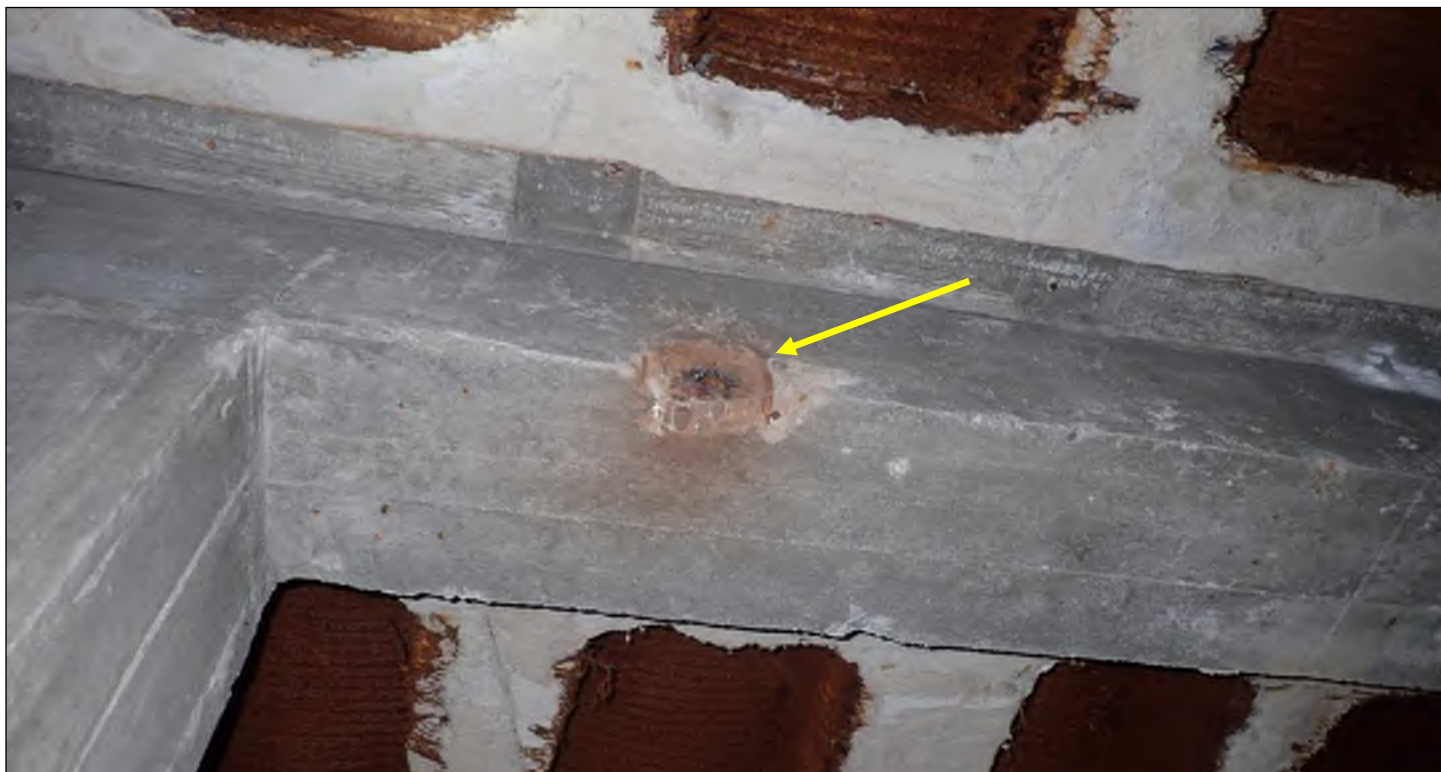
Photo 51: Spalled concrete and exposed corroded internal steel reinforcement at beam (arrow).

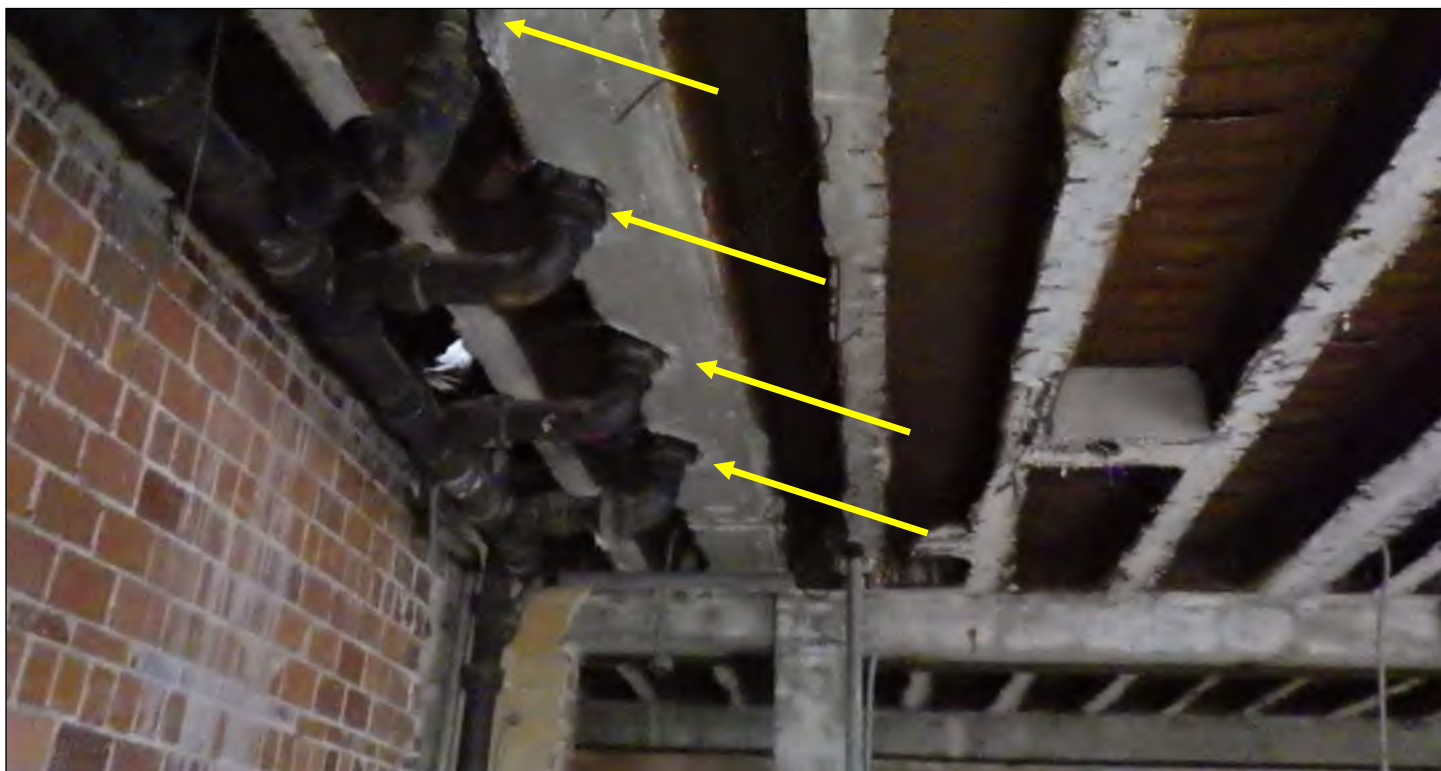
Photo 52: Piping penetrations in a double-width concrete joist (arrows).

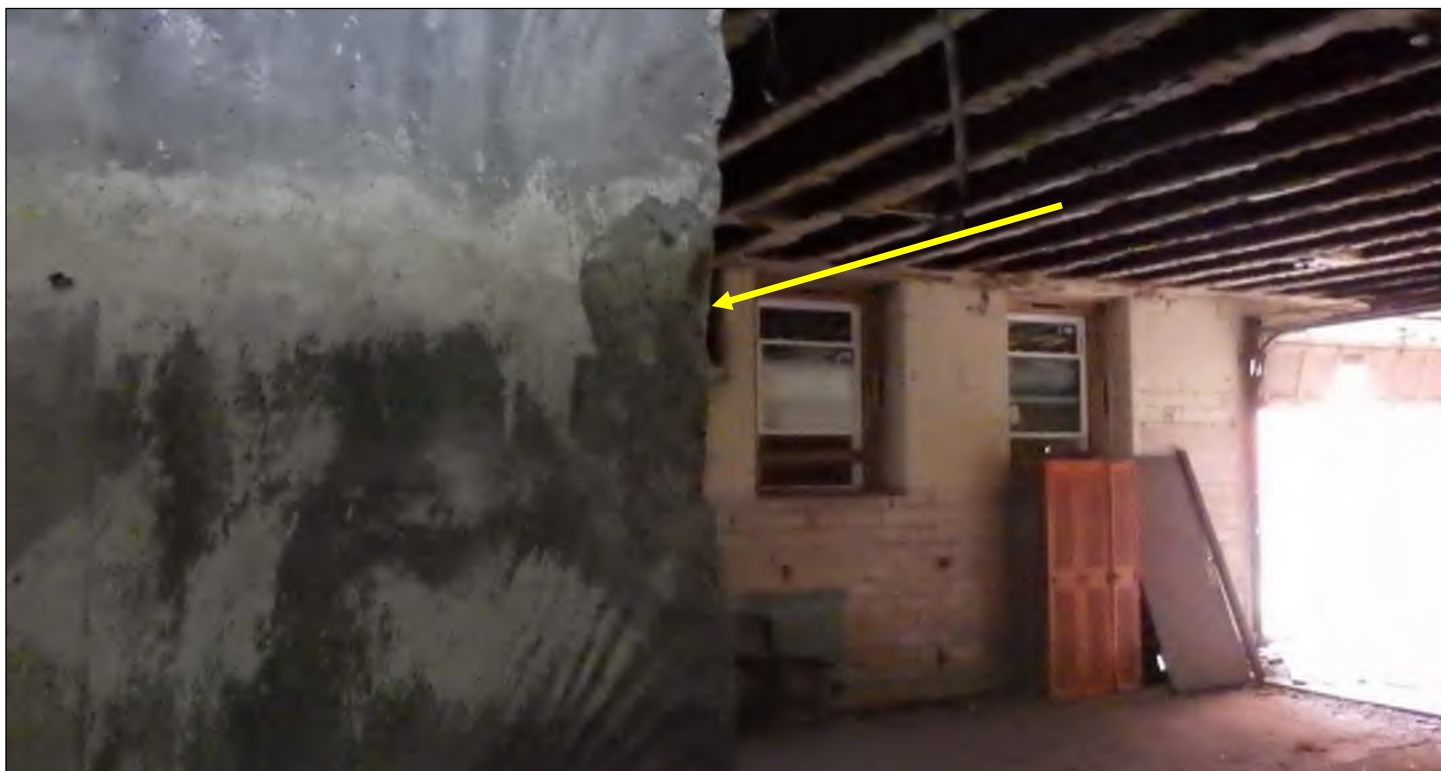
Photo 56: Missing chunk of concrete from the corner of a column (arrow).

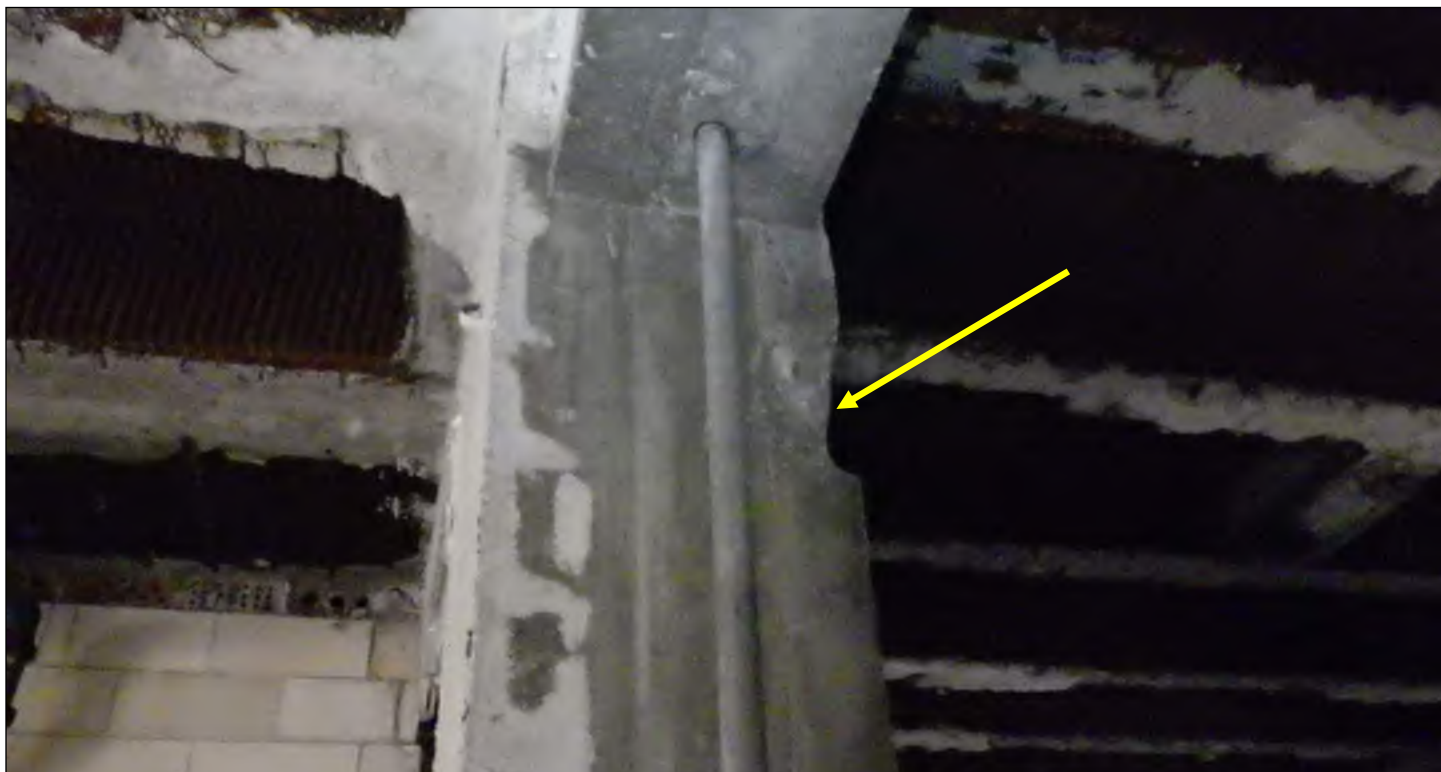
Photo 57: Missing chunk of concrete from the corner of a column (arrow).

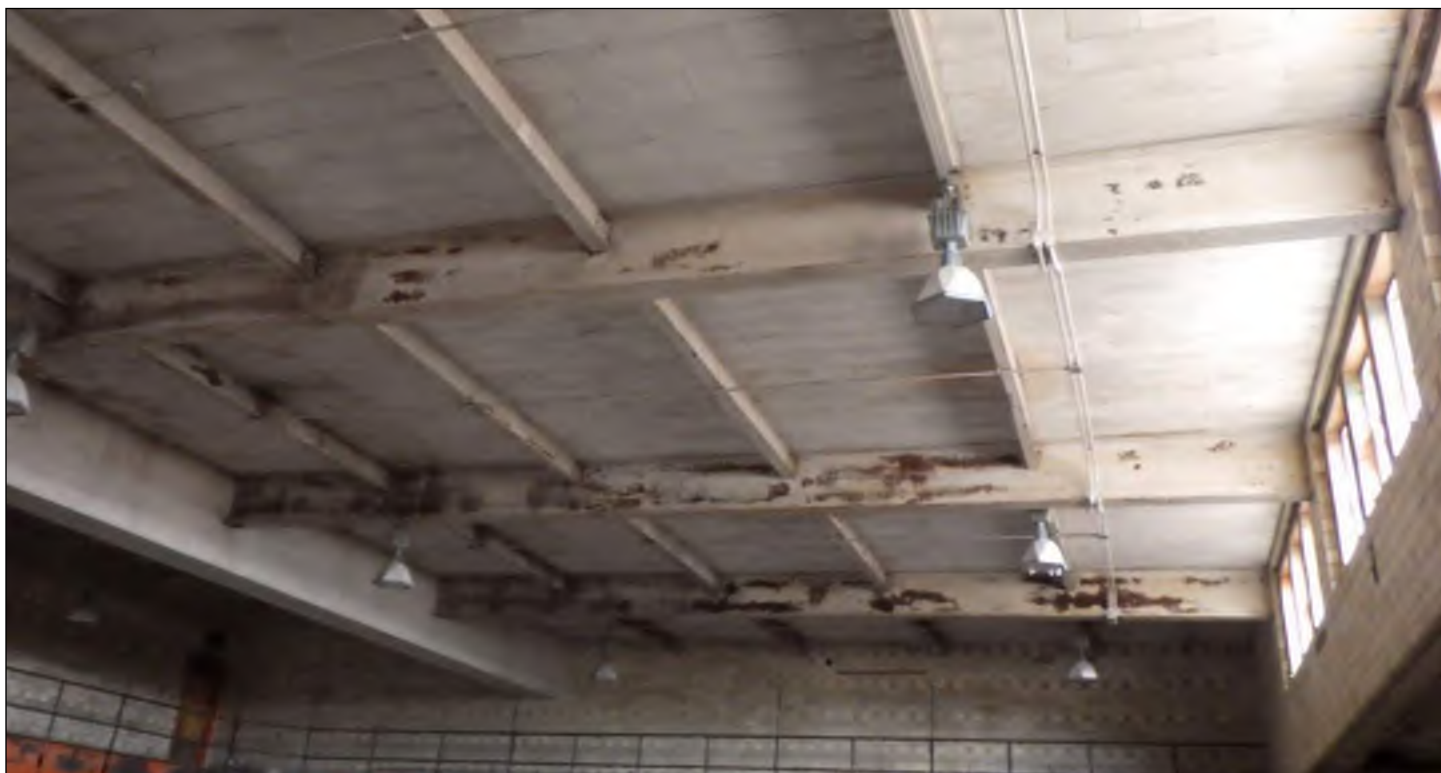
Photo 58: Overall view of steel beams supporting the gymnasium roof, looking south.

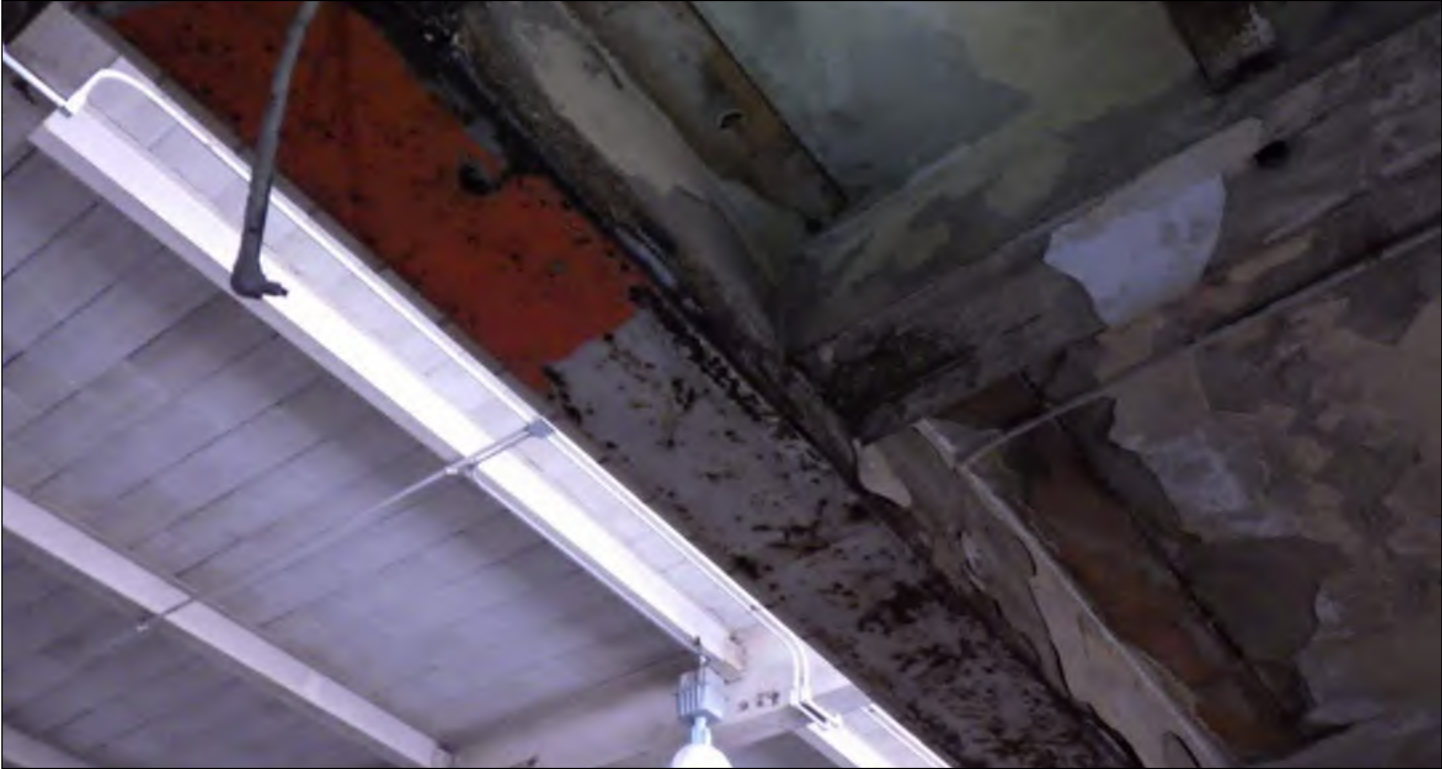
Photo 63: Corrosion (rust) at the underside of large steel beam at west side of gymnasium roof.

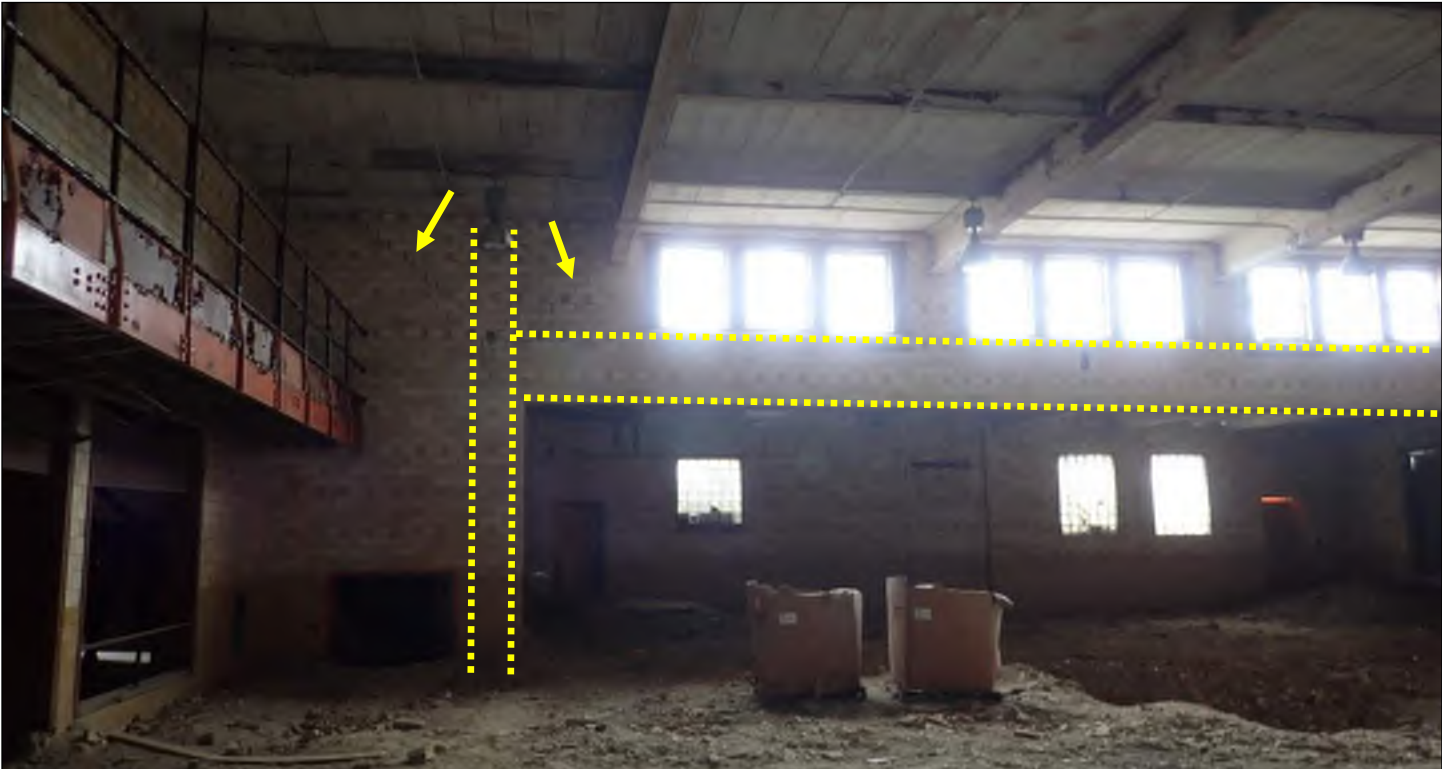
Photo 64: Cracking in clay tile finish on west gymnasium wall (arrows). Note approximate locations of obscured beam and column (dashed lines).

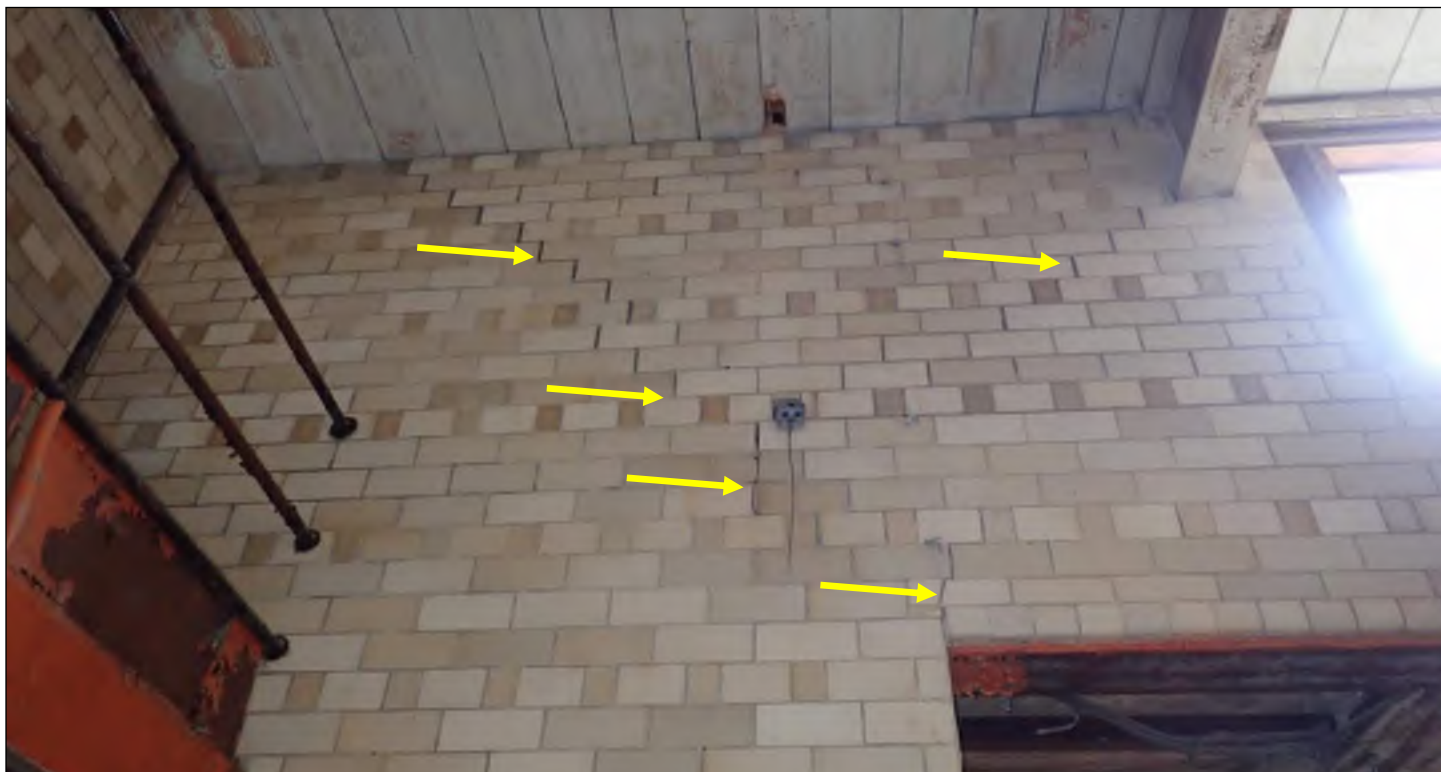
Photo 65: Close-up view of cracking in clay tile finish on west gymnasium wall.

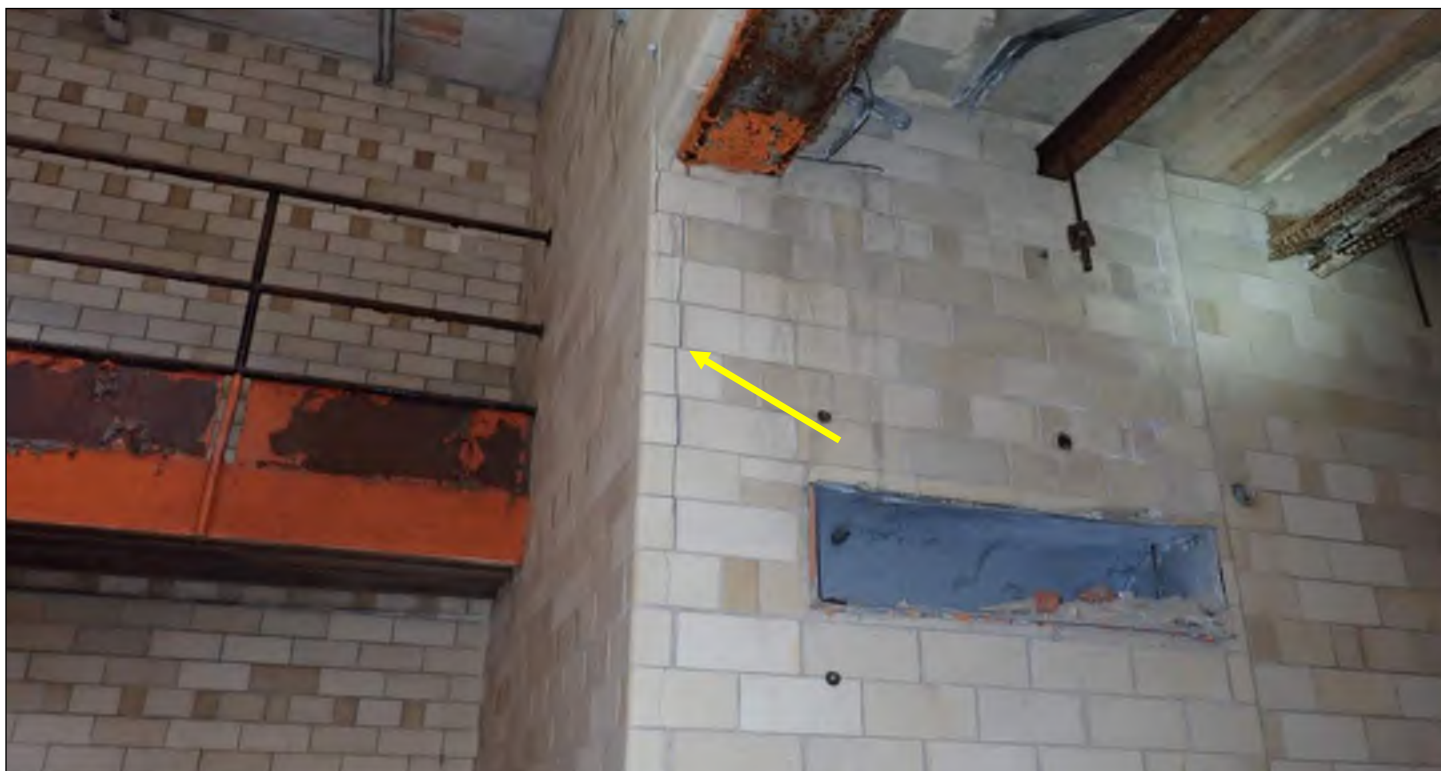
Photo 66: Close-up view of cracking in clay tile finish on west gymnasium wall.

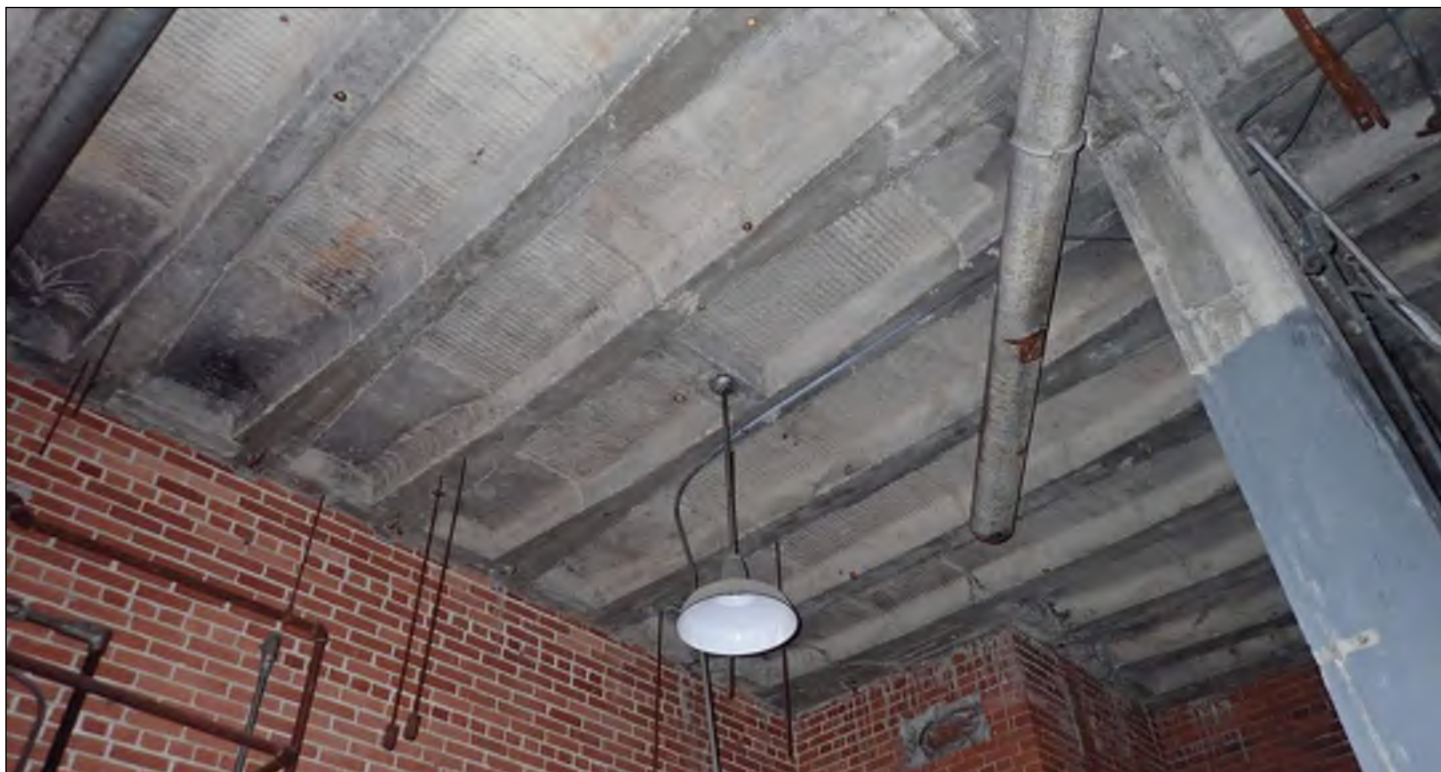
Photo 67: Underside of boiler room roof slab. Note the lack of metal tile formwork.

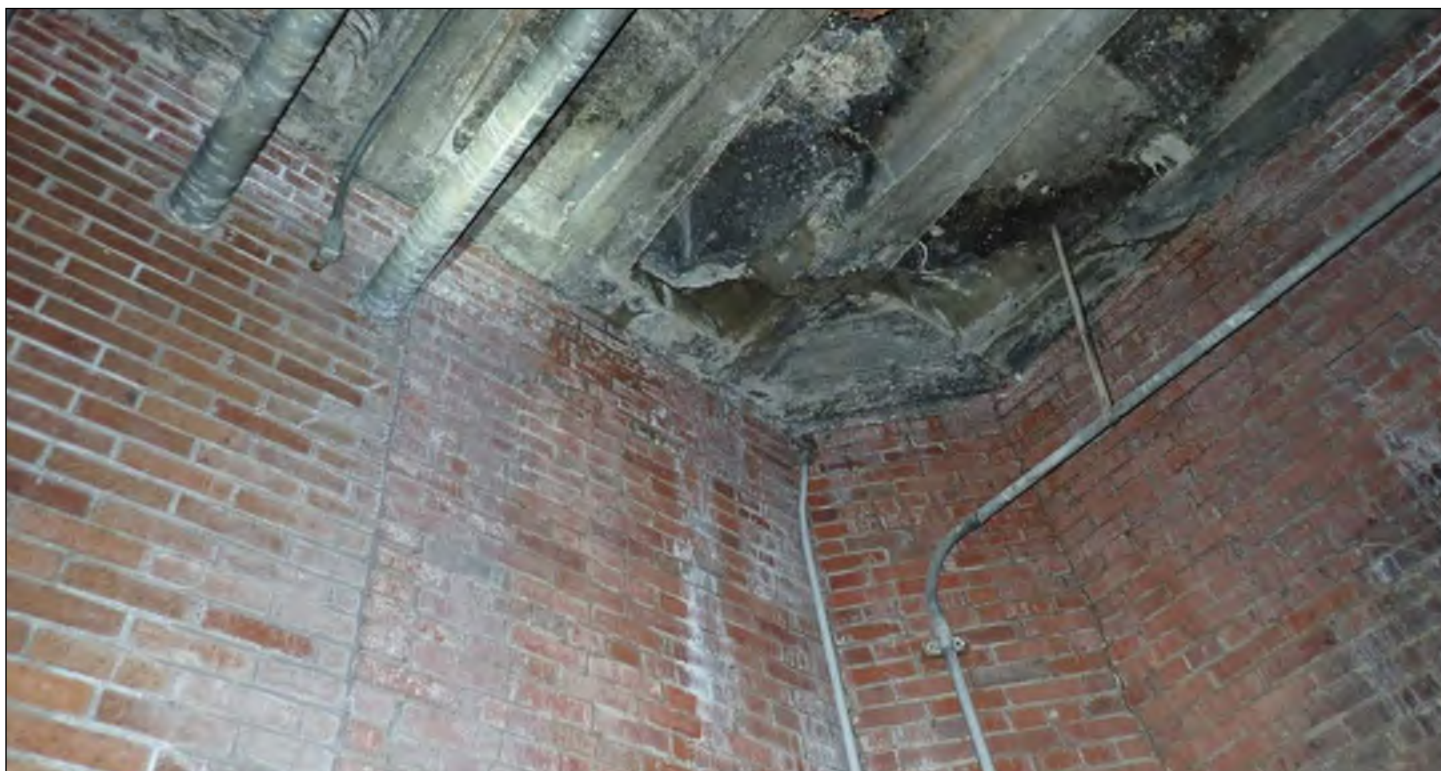
Photo 68: Cracking and water staining at the underside of the boiler room roof slab.
