**Board of Property Maintenance Appeals
Board Meeting**

**February 11, 2021
5:30 PM**

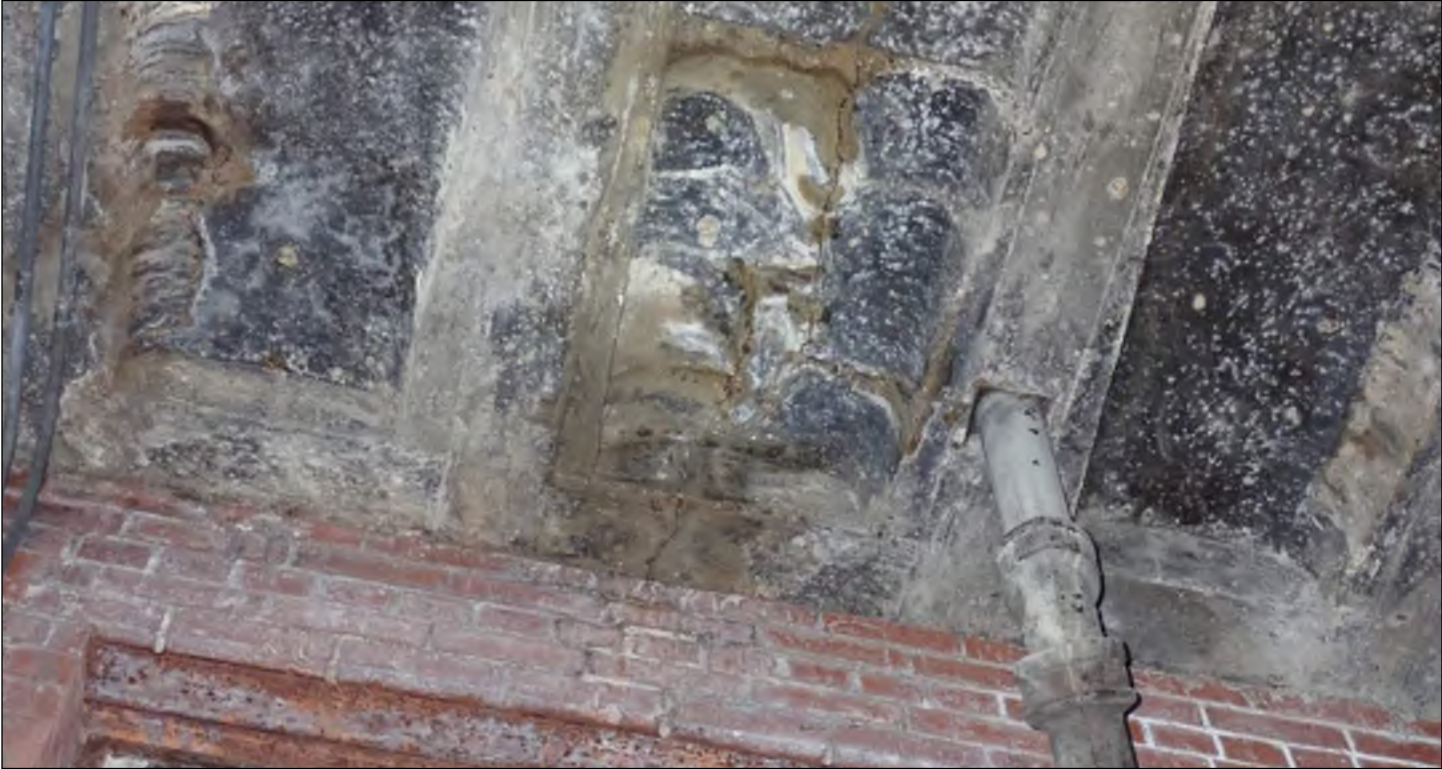
Photo 69: Cracking and water staining at the underside of the boiler room roof slab.

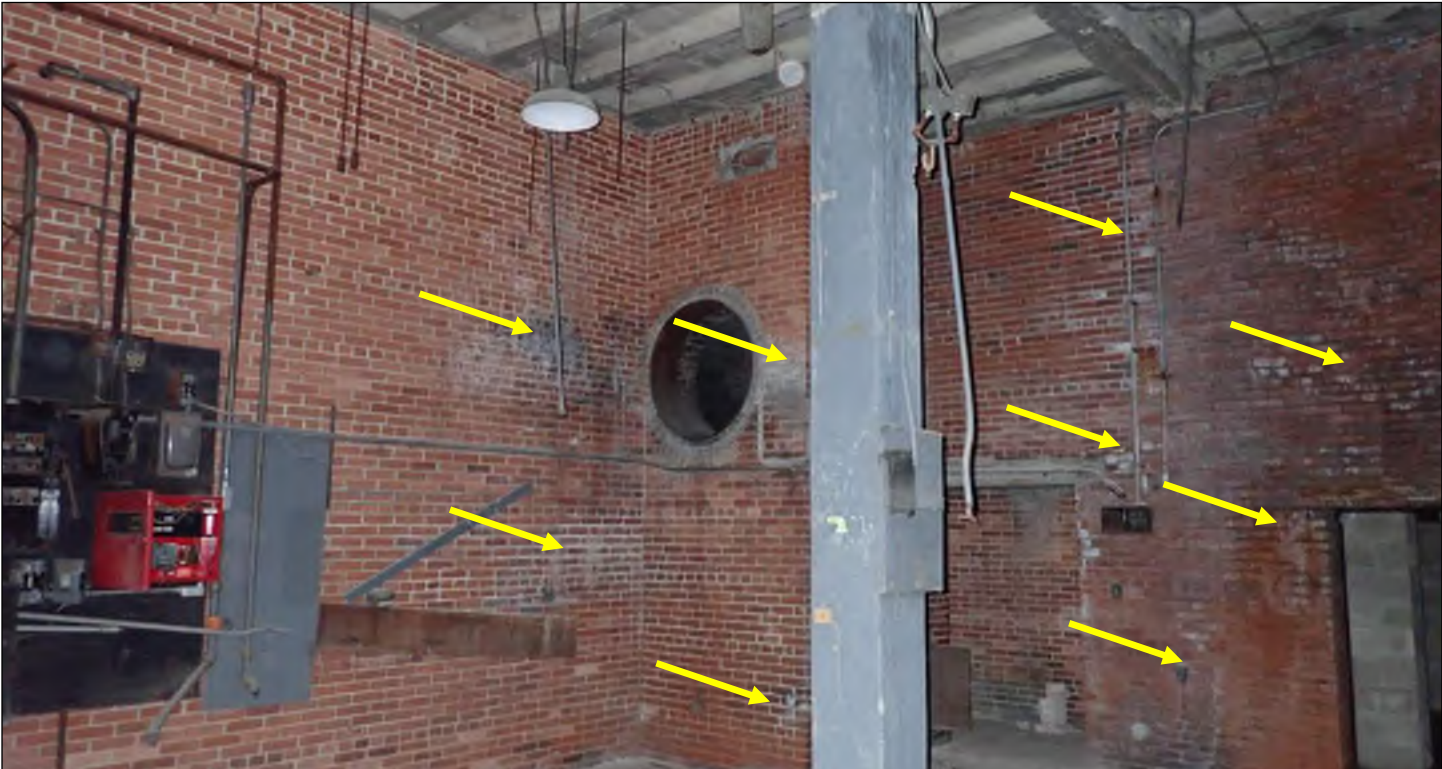
Photo 70: Efflorescence on below-grade boiler room walls (arrows).

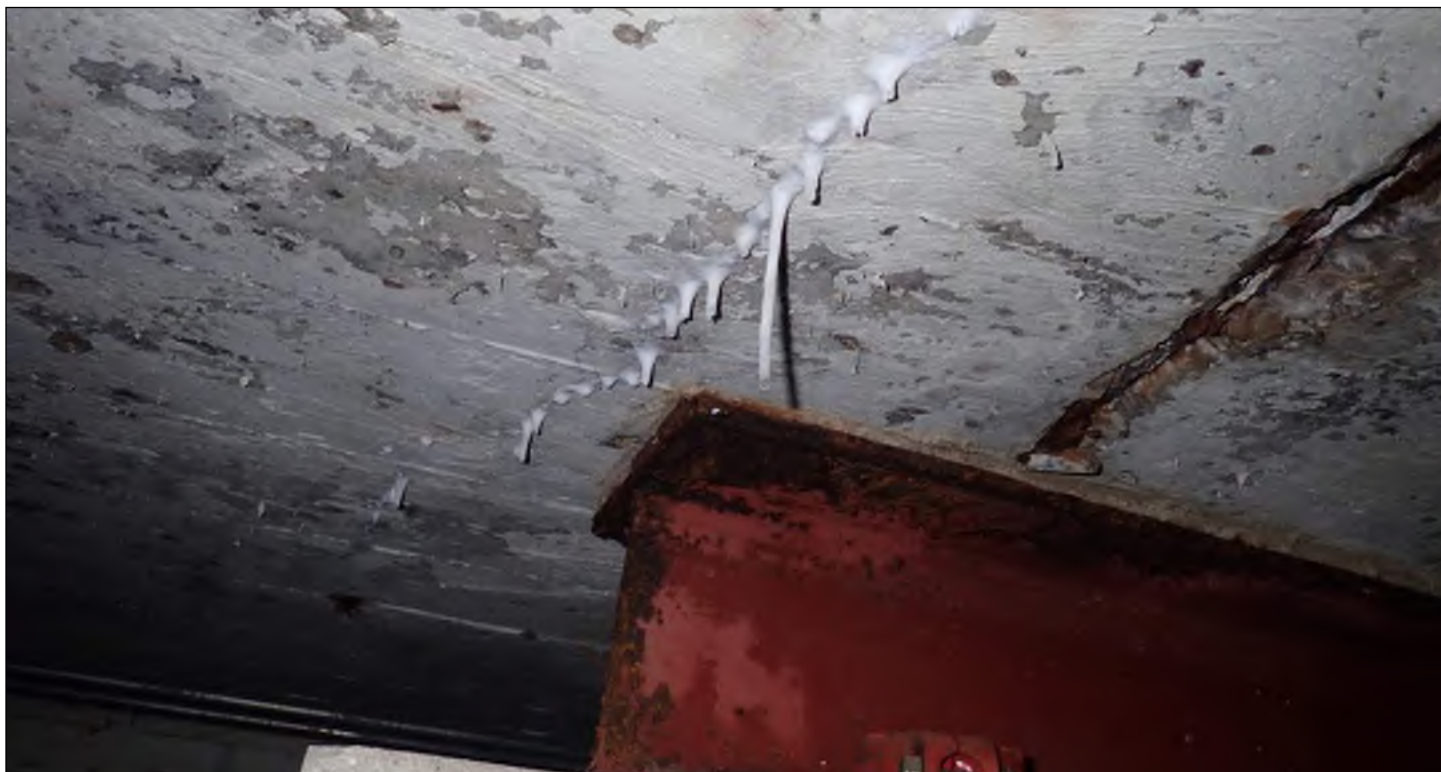
Photo 71: Mineral deposits from water infiltration.

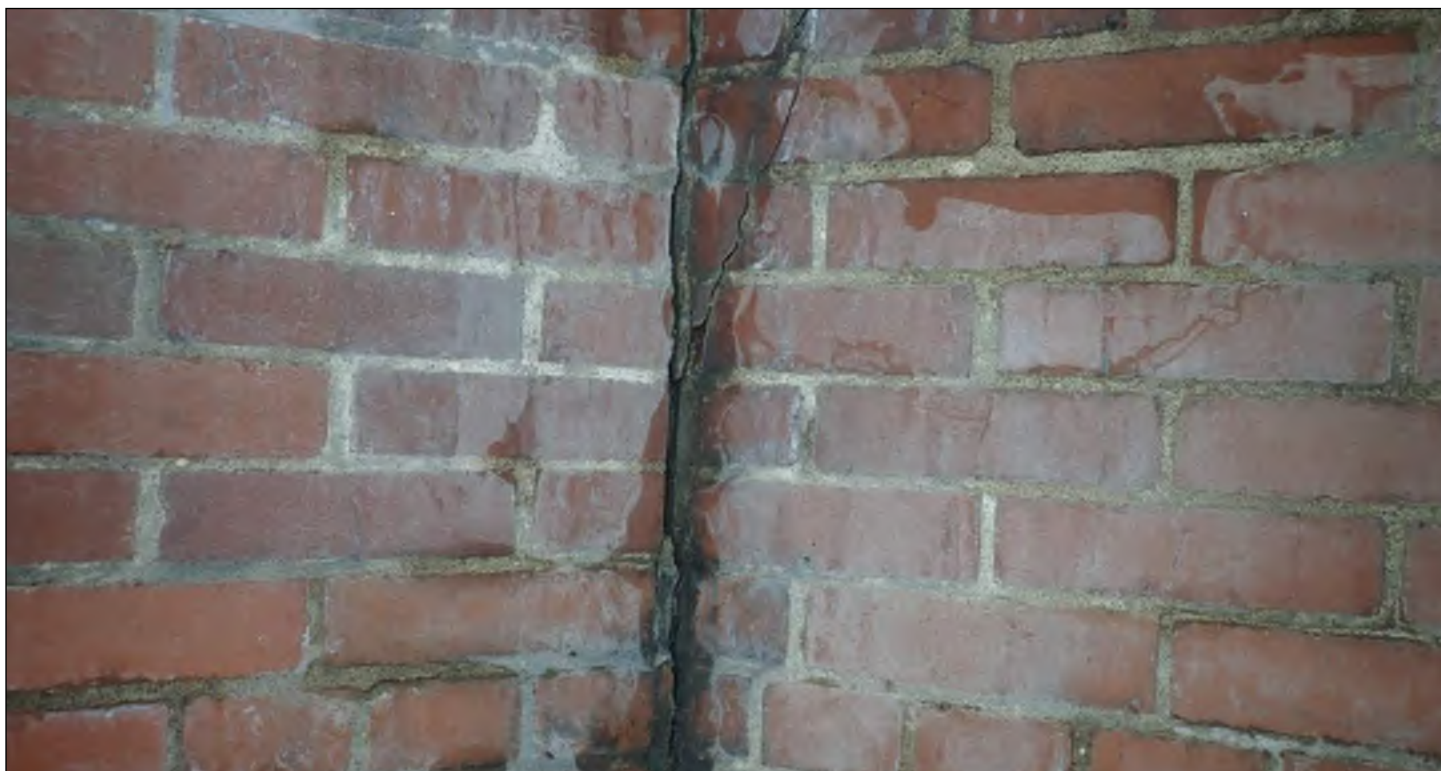
Photo 72: Active water leak at crack in below-grade boiler room wall.

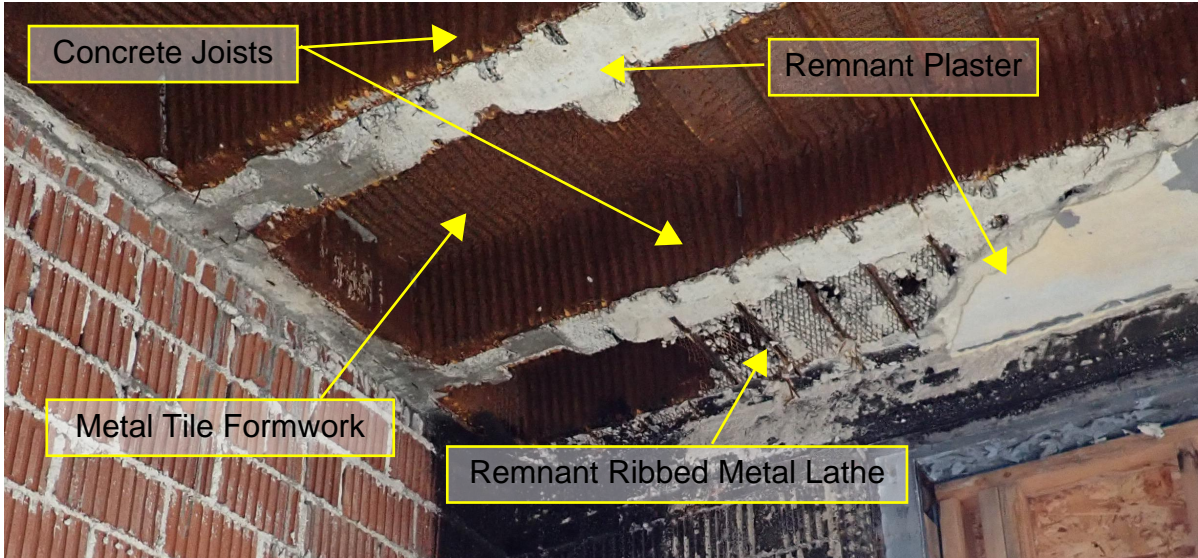
Underside of slab, showing metal tile formwork and remnant plaster on metal lathe (typical condition throughout the building).

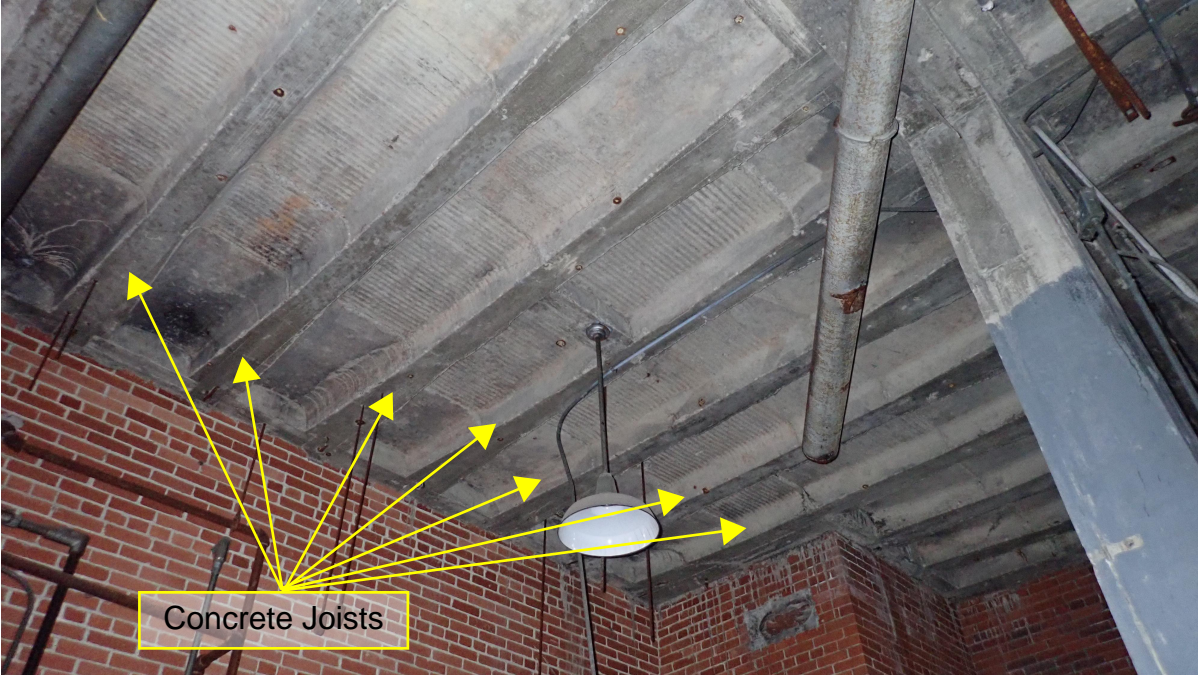
Underside of slab without metal tile formwork (either previously removed or never put in place) (condition in the boiler room).
